# Home Inspection Report

410-420 Marlborough St.  
Cornwall, Ontario K6H 4A5

Prepared for: Jared Henderson

Prepared by: Peace of Mind Home Inspections - Cornwall  
5698 County Rd. 44  
Long Sault, Ontario K0C 1P0

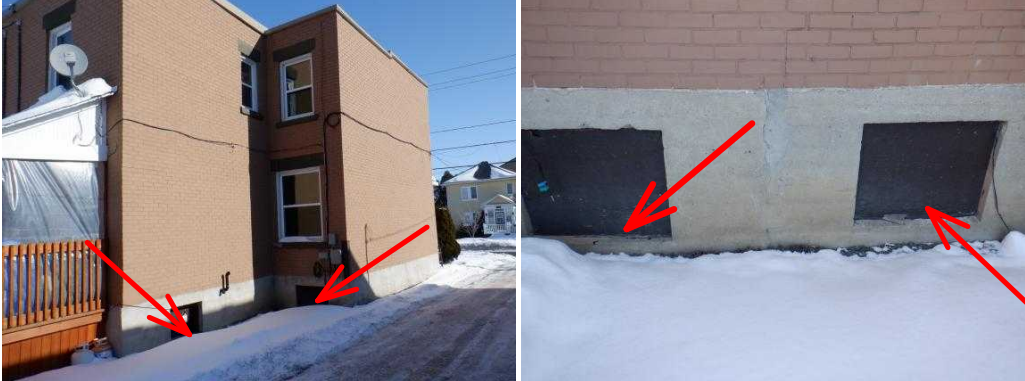
5. Basement Windows: Terminated - Deterioration on wood frame portion of terminated windows due to moisture and age. High grade noted on some basement windows. Recommend immediate improvements to prevent moisture intrusion and potential damage to the window framing. Non thermal windows. Recommend window upgrade to improve the overall efficiency of the home

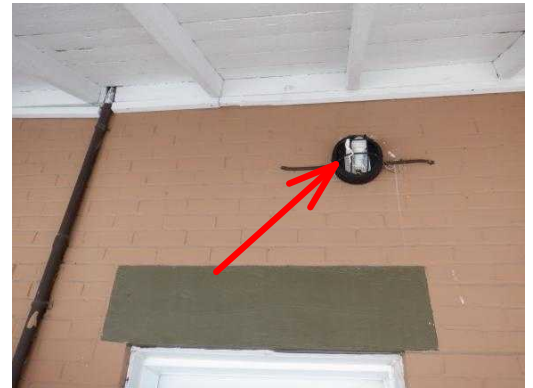
6. Exterior Lighting: Surface mount - Damaged noted. Some lights were not functional at time of the inspection - likely burnt bulbs but this was not confirmed.

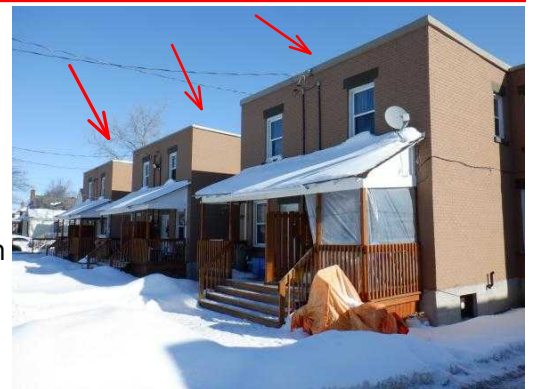
7. Main Building Roof Roof Surface Material: Rubber Membrane - Due to height and pitch of the roof along with full snow coverage the roof was not visible for inspection. The old MLS Listing stated the rubber membrane roof was updated in the last 15 years. This would make the roofing material older. A proper view and inspection of the roof membrane will be available in the spring once the snow melts. We recommend an annual inspection and tune-up to minimize the risk of leakage and to maximize the life of roofs.

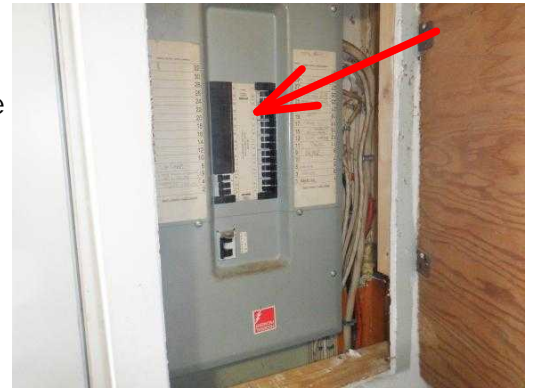
9. Main - Service and Distribution Panel - Unit 410 Electric Panel Manufacturer: Federal Pioneer Stab lok - Note: Federal Pioneer Stab Lok panels are discontinued. The breakers will be difficult to find and will likely be expensive. These type of panels have a history of not tripping. The rarity of the breakers will lead to these panels having to be updated in the future.

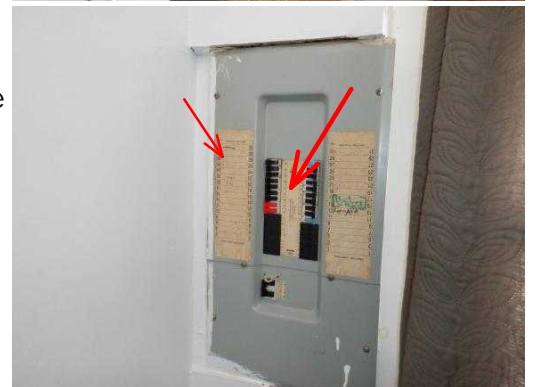
10. Basement - Service and Distribution Panel - Unit 412 Electric Panel Manufacturer: Federal Pioneer Stab lok - Note: Federal Pioneer Stab Lok panels are discontinued. The breakers will be difficult to find and will likely be expensive. These type of panels have a history of not tripping. The rarity of the breakers will lead to these panels having to be updated in the future. Panel was not clearly labeled. Recommend labeling each breaker clearly and accurately.

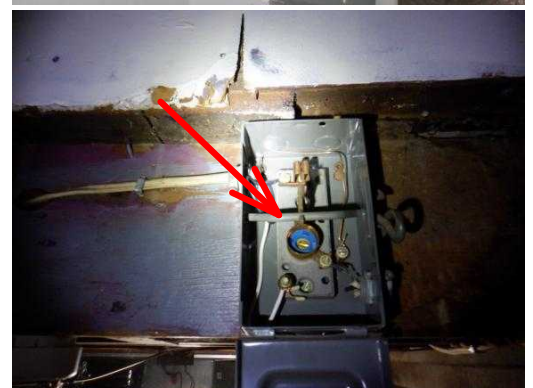
11. Basement Sub Panel - Unit 412 Electric Panel Manufacturer: Taylor Electric Company - Panel had no fuses and was not being used at time of the inspection. Recommend proper termination of all unused panels.

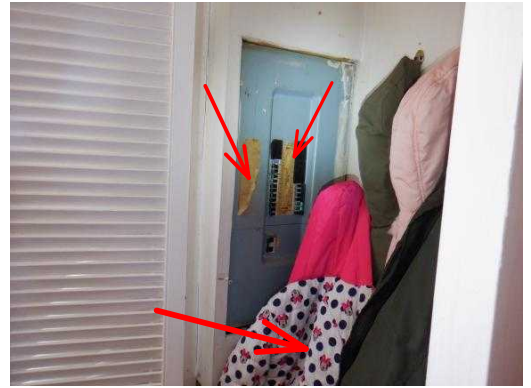
12. Main - Service and Distribution Panel - Unit 414 Electric Panel Manufacturer: Federal Pioneer Stab lok - Recommend three feet of clearance in front of all electrical panels allowing for adequate access. Note: Federal Pioneer Stab Lok panels are discontinued. The breakers will be difficult to find and will likely be expensive. These type of panels have a history of not tripping. The rarity of the breakers will lead to these panels having to be updated in the future. Panel was not clearly labeled. Recommend labeling each breaker clearly and accurately.

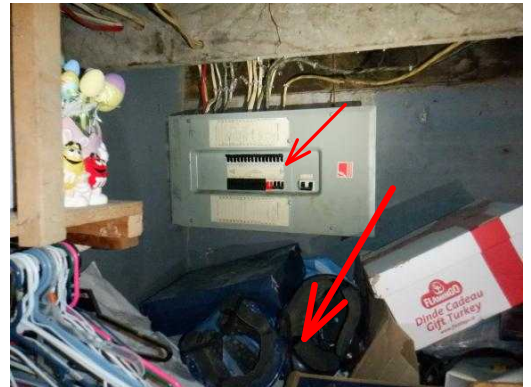
13. Basement - Service and Distribution Panel - Unit 416 Electric Panel Manufacturer: Federal Pioneer Stab lok - Recommend three feet of clearance in front of all electrical panels allowing for adequate access. Note: Federal Pioneer Stab Lok panels are discontinued. The breakers will be difficult to find and will likely be expensive. These type of panels have a history of not tripping. The rarity of the breakers will lead to these panels having to be updated in the future.

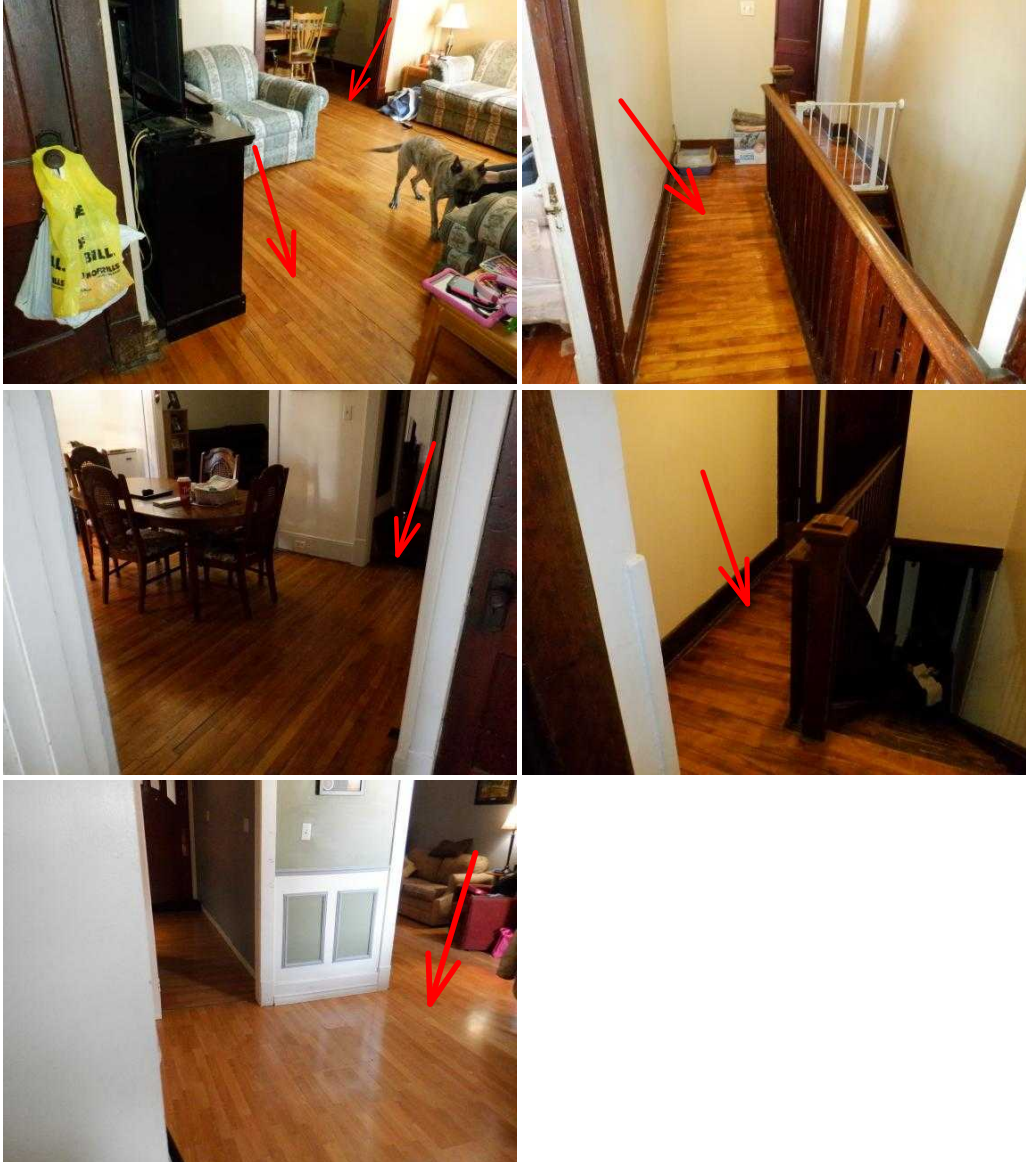
15. Differential Movement: Settlement Noted - See foundation, porch and stoop notes. Settlement is noted by the sloping floors. If concerned about this settlement or further settlement continues, recommend consulting a qualified structural contractor. Finishes, insulation, furnishings and storage conceal structural components, preventing/restricting inspection. It is

not possible to determine the presence or extent of ongoing movement based on a one-time visit.

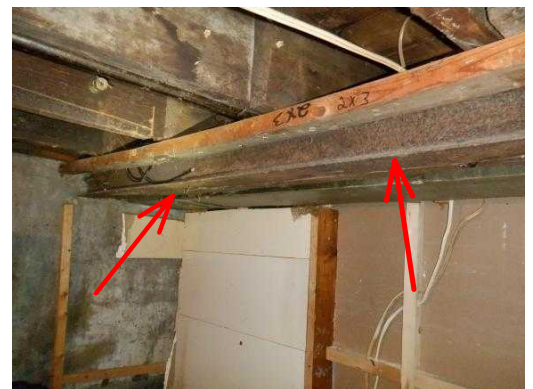
16. Beams: Steel I-Beam - Rusting and sagging was noted on older beam.

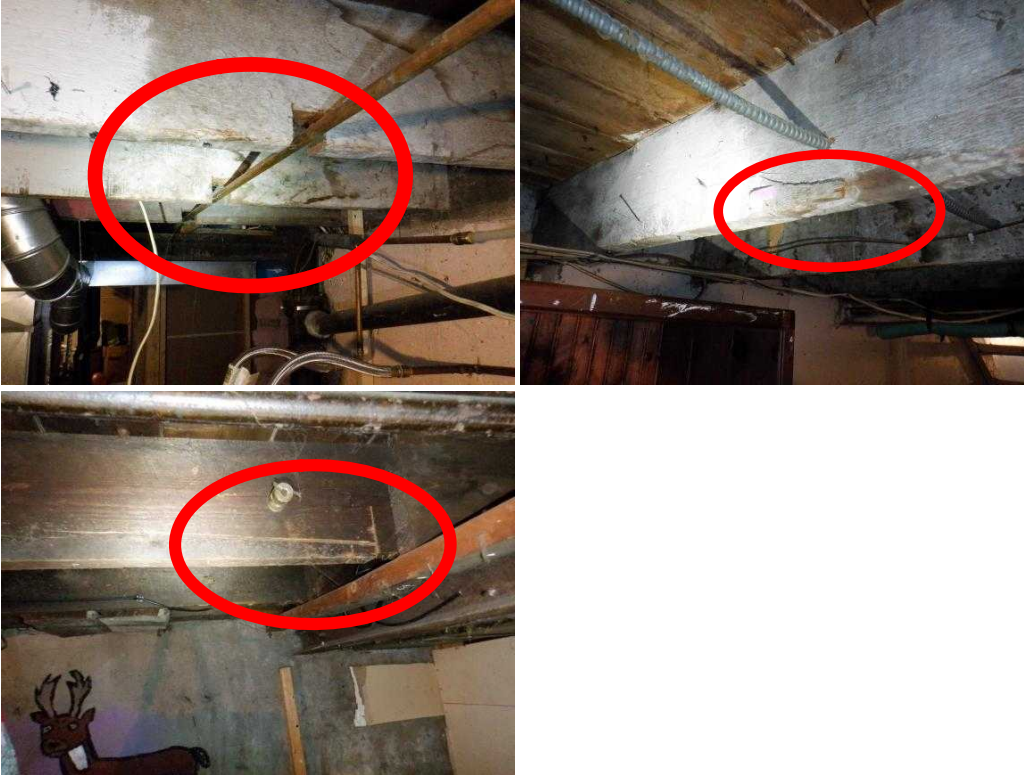
17. Joists/Trusses: 2x8 - Any areas that have finished ceilings will not allow a full inspection of the joists. Age appropriate deterioration noted on most visible joists. Monitor age Appropriate cracking and brace joists should cracks enlarge past their current size. Older joists had wide spacing which allowed for some sagging of the joists. Joists have been modified notched and should be monitored for cracking. Brace should any cracking occur. Larger cracked joists in Units 416 and 414 require bracing repairs to help maintain the integrity of the joists. Previous bracing repairs noted.

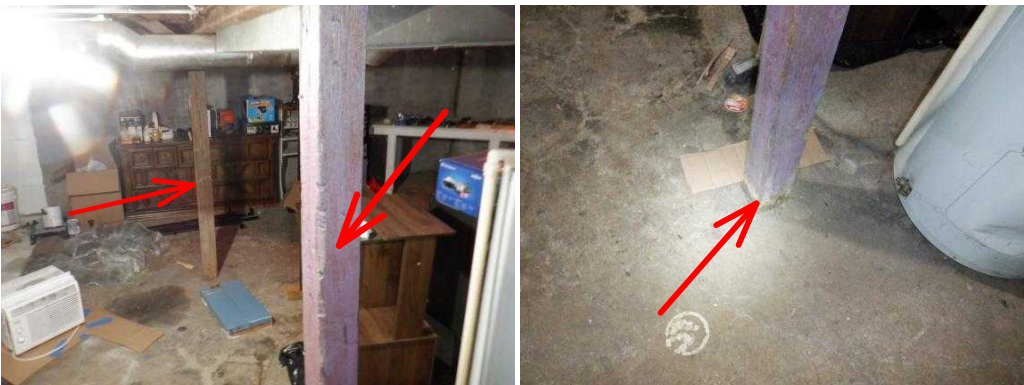
18. Piers/Posts: Wood posts - Some Footings/Piers were not visible but standard construction is generally below the concrete floor. Deterioration was noted on older wood posts with some moisture damage present at the bases. Minor movement noted. Posts should be upgraded in the future.

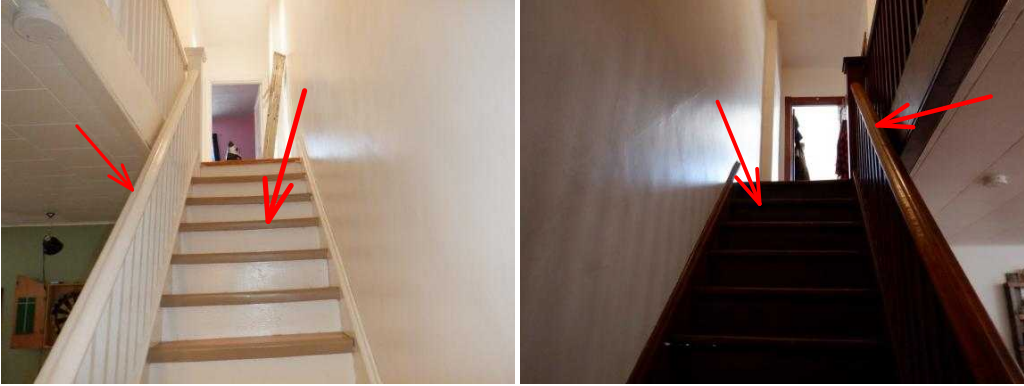
20. Stairs/Handrails: Wood stairs with wood handrails - Settlement on the stairs were comparable to the rest of the home. Loose, deteriorated and soft steps require improvements. Some railing system height is low and does not meet today's safety standards. Secure loose railings for safety and to prevent potential damage to the railings.

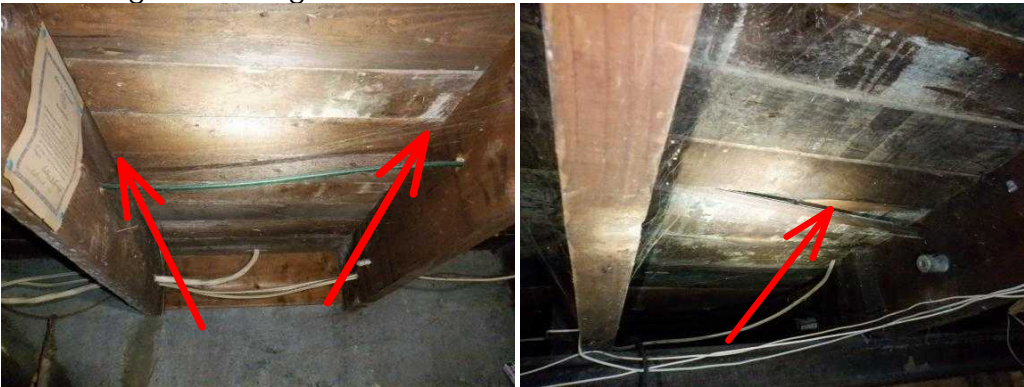
21. Subfloor: Dimensional wood - Unable to inspect portions of subfloor as basement ceilings were finished. Age appropriate deterioration and repairs for renovations noted on visible sub floor. Water stains noted on subfloor were dry on the moisture meter at time of the inspection. Squeak in flooring noted in numerous areas throughout the home. This is a difficult item to repair and is usually tolerated by the home owner until more intensive renovations are being completed. Soft and damaged flooring should be braced.

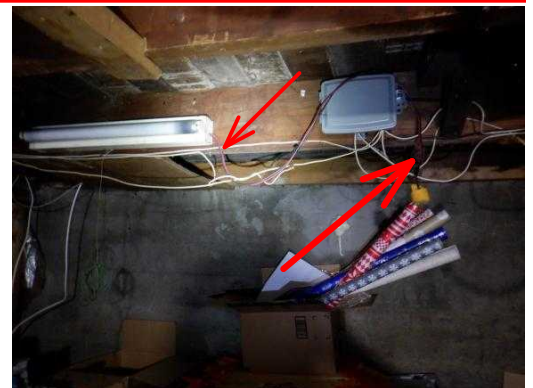
22. Entire Basement Area - Unit 410 Basement Electrical: 110 VAC Outlets and Lighting Circuits - Improper electrical noted. Recommend repairs by a qualified electrician.

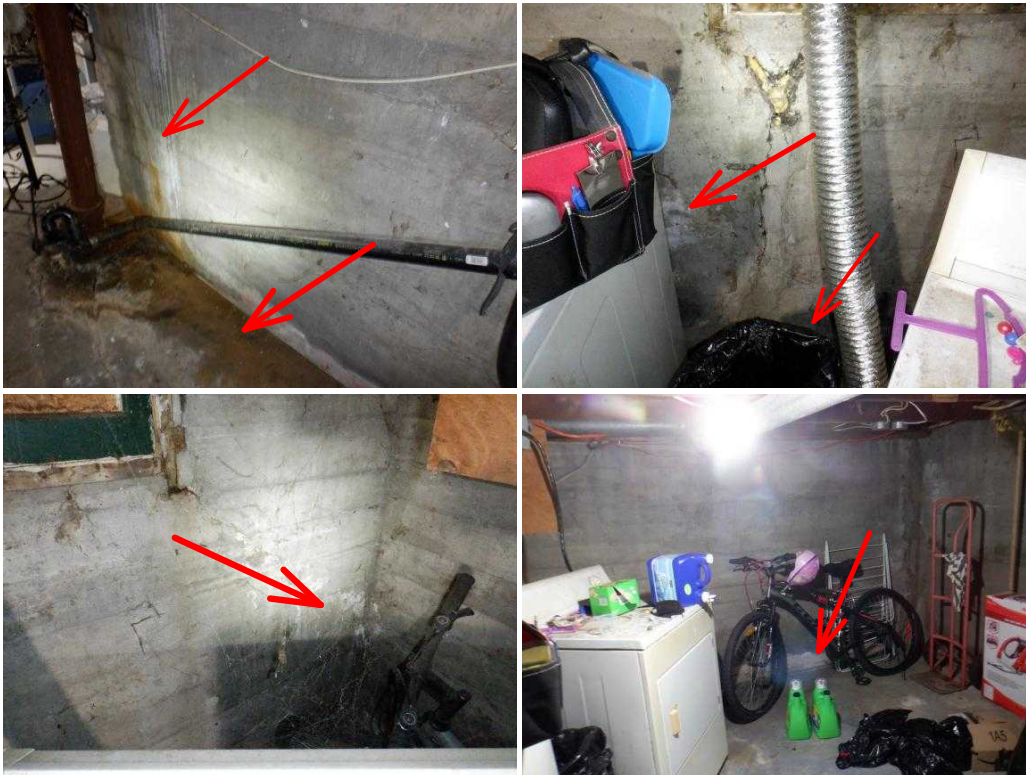
24. Entire Basement Area - Unit 410 Basement Moisture Location: Moisture signs in the basement area. Water stains present. Efflorescence noted on basement walls from past moisture. Ongoing seepage present. These older basements will always likely have some leakage and should be cared for with this in mind. There are signs of previous water penetration. Recommend referring to the seller to determine the extent of previous basement moisture. Musty odors and dampness was noted throughout the basement area. A dehumidifier and improved air circulation are recommended to reduce potential condensation problems in the basement. No moisture barrier was present under the partition walls and concrete floor. This situation will allow for dampness from the concrete to enter the wood.

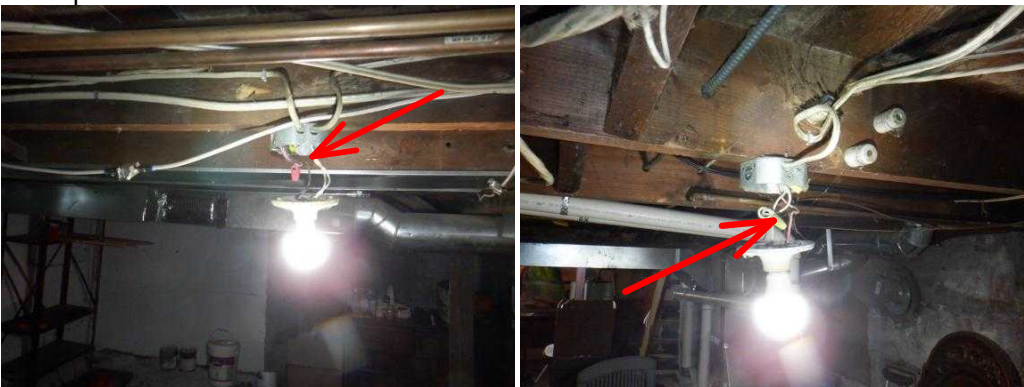
26. Entire Basement Area - Unit 412 Basement Electrical: 110 VAC Outlets and Lighting Circuits - Loose fixtures should be secured to prevent movement and potential wiring becoming loose. Open "knock-out" hole- insert "blank-out" cap to close off opening. Install missing junction box cover plates.

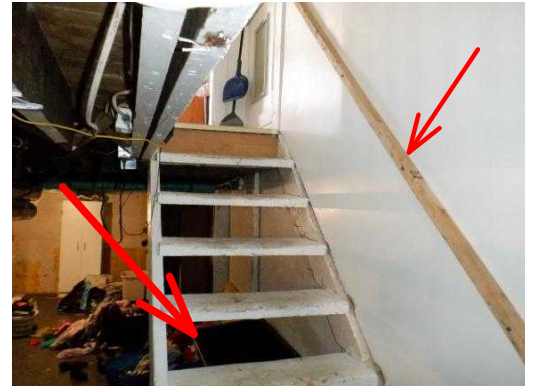
30. Entire Basement Area - Unit 414 Basement Basement Stairs/Railings: Wood stairs with wood handrails - Deteriorated older steps require improvements. Recommend improved railings. As with the case of most older homes the basement stairs have limited clearances and/or don't meet today's standards. Caution should be used at all times when using the stairs for safety.

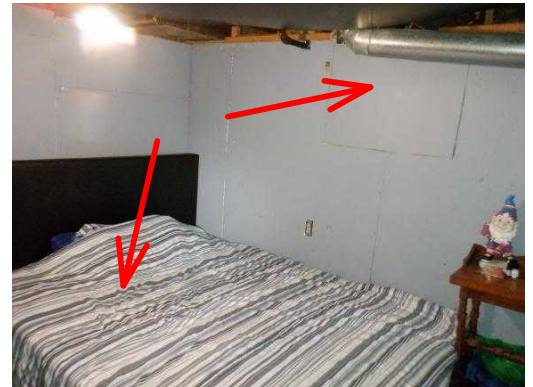
31. Entire Basement Area - Unit 416 Basement Windows: Terminated - Note: Basements with bedrooms require a proper size window for an egress. Basement window egresses should have a minimum of 3.8ft with no dimension less than 15 inches and can be opened.

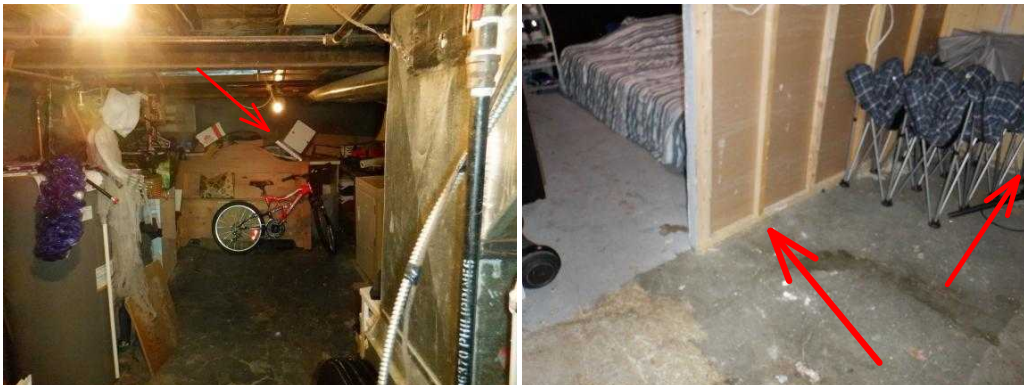
32. Entire Basement Area - Unit 416 Basement Moisture Location: Moisture signs in the basement area. Water stains present. Efflorescence noted on basement walls from past moisture. These older basements will always likely have some leakage and should be cared for with this in mind. There are signs of previous water penetration. Recommend referring to the seller to determine the extent of previous basement moisture. Musty odors and dampness was noted throughout the basement area. A dehumidifier and improved air circulation are recommended to reduce potential condensation problems in the basement. No moisture barrier was present under the partition walls and concrete floor. This situation will allow for dampness from the concrete to enter the wood.

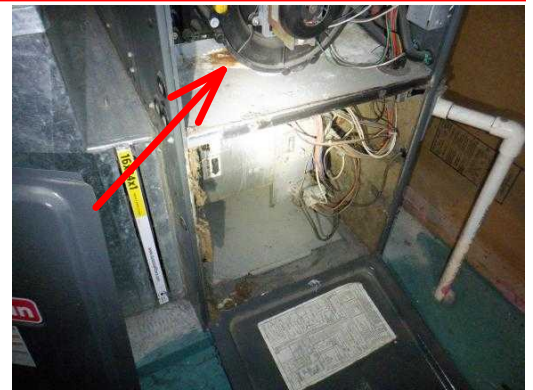
34. Basement Unit 420 Heating System Heating System Operation: Functional at time of the inspection - Unit is in serviceable condition, but is an older unit (17 Years) and should be regularly maintained. Life expectancy of a high efficiency furnace is 15 - 20 years. Service and cleaning recommended on an annual basis to ensure proper function and to prolong the stated design life of the unit. Rusting noted inside the cabinet but area was dry at time of the inspection. Likely due to past condensate leak but this was not confirmed. Owner may have insight.

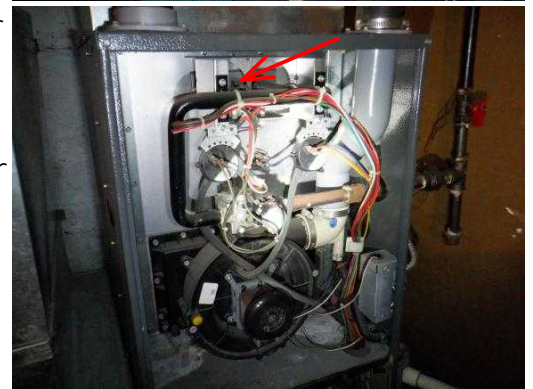
35. Basement Unit 420 Heating System Heat Exchanger: 2 Burner - The heat exchanger is substantially concealed and could not be fully inspected. Advanced deterioration was noted on older burners due to age but no cracks were visible at time of the inspection. This should be inspected by your heating contractor during your next cleaning.

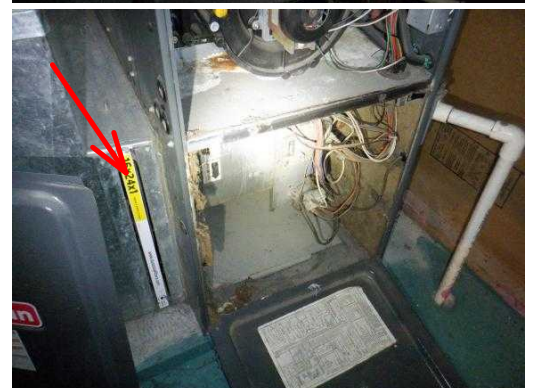
36. Basement Unit 420 Heating System Blower Fan/Filter: Drive with disposable filter - Filter is dirty, Change filter regularly. Recommend using better quality filters.

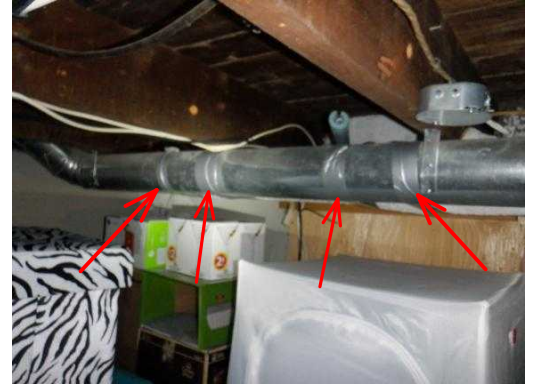
37. Basement Unit 420 Heating System Distribution: Metal duct - Some duct work was not visible due to interior finishings. Recommend using proper aluminum tape to seal all duct connections and terminations. Ducts were dirty and in need of a cleaning.

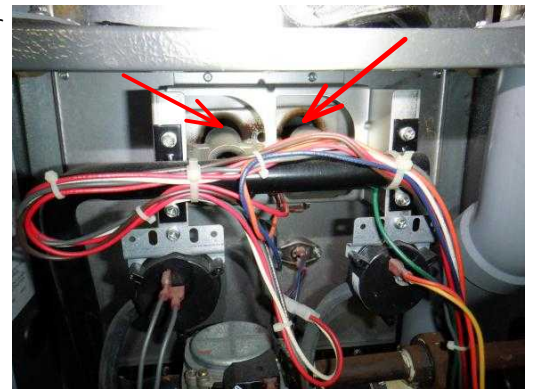
38. Basement Unit 418 Heating System Heat Exchanger: 2 Burner - Advanced deterioration was noted on older burners due to age but no cracks were visible at time of the inspection. This should be inspected by your heating contractor during your next cleaning.

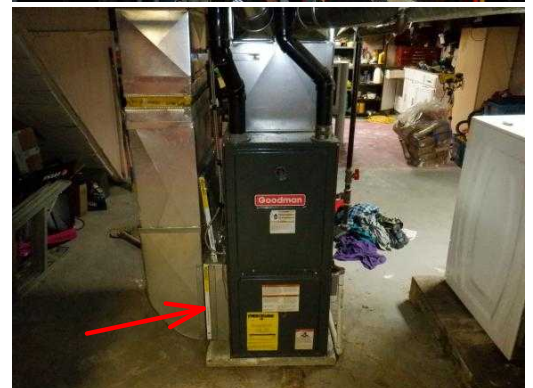
39. Basement Unit 418 Heating System Blower Fan/Filter: Drive with disposable filter - Filter is dirty. Recommend using better quality filters. Change filter regularly

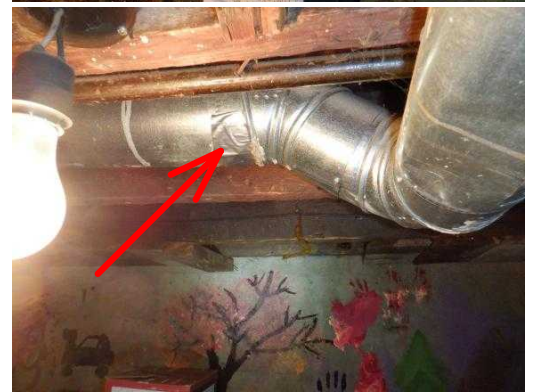
42. Basement Unit 416 Heating System Distribution: Metal duct - Some duct work was not visible due to interior finishings. Rusting and deterioration was present on older ducts but no penetrations were noted. Ducts were dirty and in need of a cleaning. Recommend using proper aluminum tape to seal all duct connections and terminations.

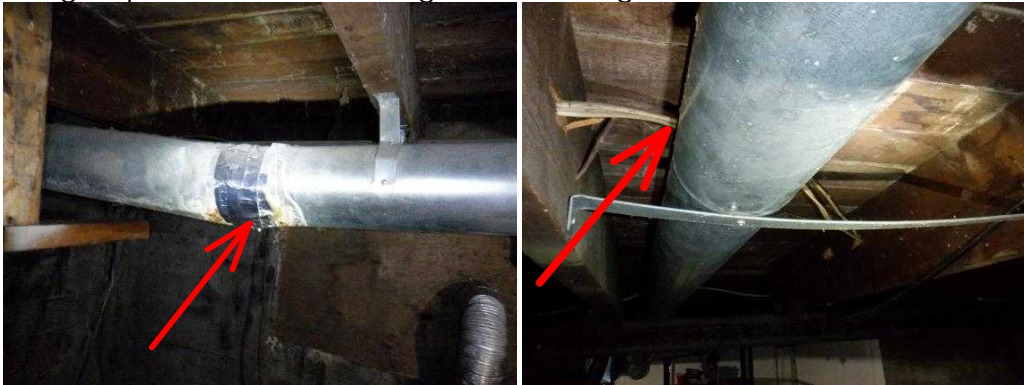
49. Basement Unit 412 Heating System Distribution: Metal duct - Some duct work was not visible due to interior finishings. Ducts were dirty and in need of a cleaning. Rusting and deterioration was present on older ducts but no penetrations were noted. Recommend using proper aluminum tape to seal all duct connections and terminations. Insulation required between duct work and wiring to prevent over heating of the wiring.

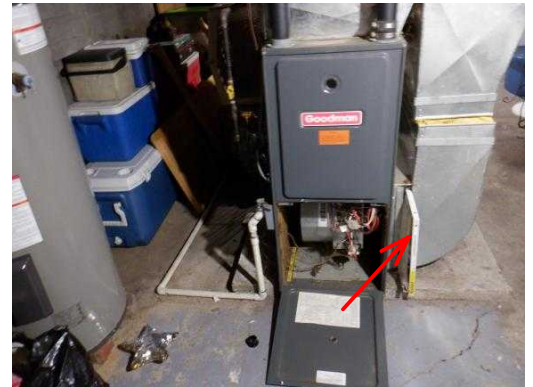
52. Basement Unit 410 Heating System Blower Fan/Filter: Drive with disposable filter - Filter is extremely dirty. Change filter regularly. Recommend using better quality filters. Install proper size filter.

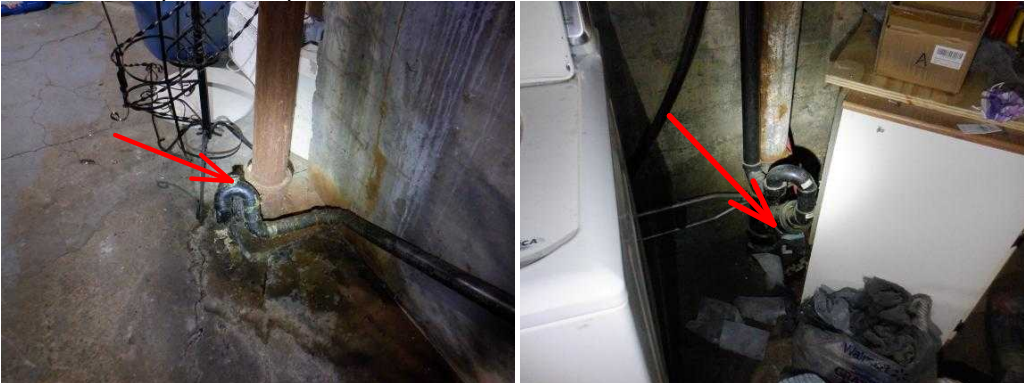
56. Service Caps: Accessible, Missing - Recommend installation of a proper main clean out. Prior clean out cap was replaced with another drain.

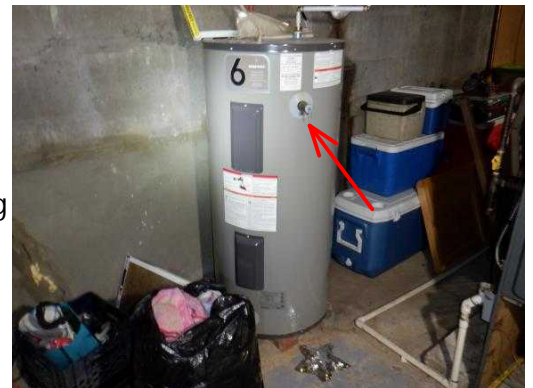
57. Basement - 410 Water Heater TPRV and Drain Tube: Copper valve and missing tube - This safety valve cannot be tested during this inspection. For safety reasons, and to prevent potential scalding, the water heater temperature setting should not be above 120 degrees. The hot water temperature should be checked immediately upon moving in. Install missing TPRV tube

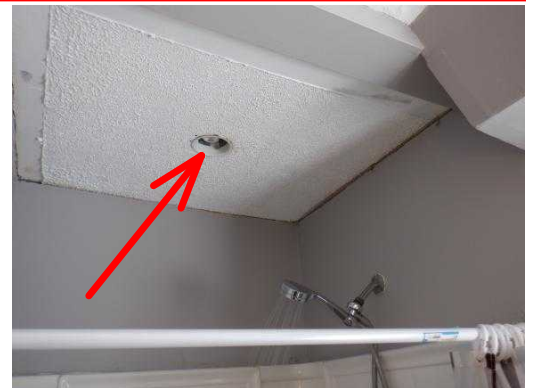
59. Second Floor - Unit 414 Bathroom Electrical: 110 VAC GFCI, 110 VAC lighting circuits - The shower light fixture was not protected from moisture. Recommend improvements.

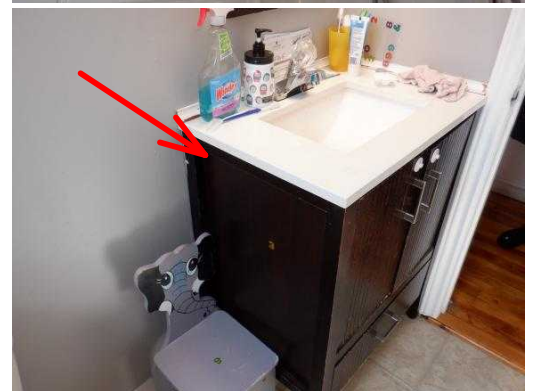
60. Second Floor - Unit 414 Bathroom Counter/Cabinet: Granite like and laminate - Some damages noted. Signs of past moisture under the cabinet. Area was dry on the moisture meter at time of the inspection. Cabinet not properly mounted to wall. Recommend improvements to prevent movement and potential leakage from water and drain pipes.

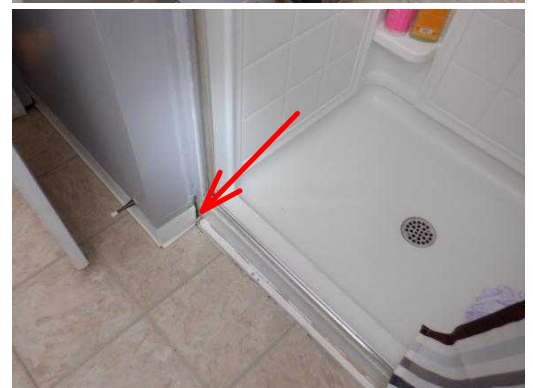
61. Second Floor - Unit 414 Bathroom Shower/Surround: Plastic pan and plastic surround - Outside corners had water signs that were dry on the moisture meter at time of the inspection. Monitor. Maintain caulking in this space to prevent moisture intrusion and water damage behind the wall.

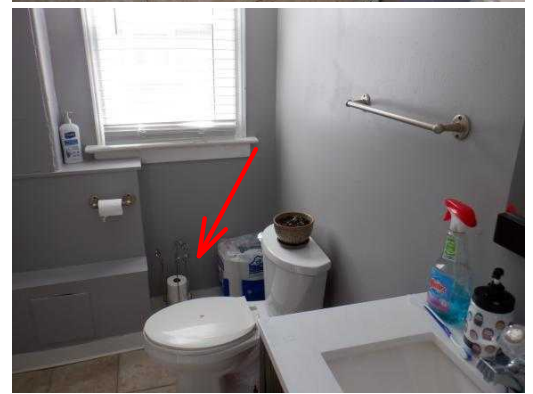
63. Second Floor - Unit 414 Bathroom HVAC Source: Missing - A HVAC source should be present in each room of the home.

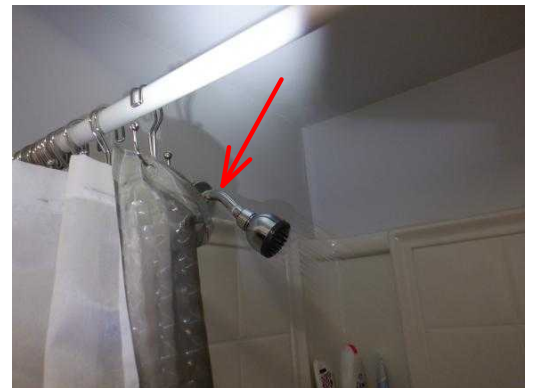
64. Second Floor - Unit 412 Bathroom Faucets/Traps: Fixtures with ABS Trap - The shower head stem is loose. Recommend securing to prevent damage to the supply line and possible water damage.

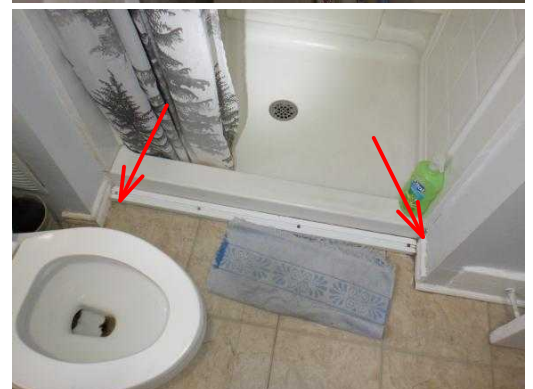
65. Second Floor - Unit 412 Bathroom Shower/Surround: Plastic pan and plastic surround - Outside corners had water signs that were dry on the moisture meter at time of the inspection. Monitor. Maintain caulking in this space to prevent moisture intrusion and water damage behind the wall.

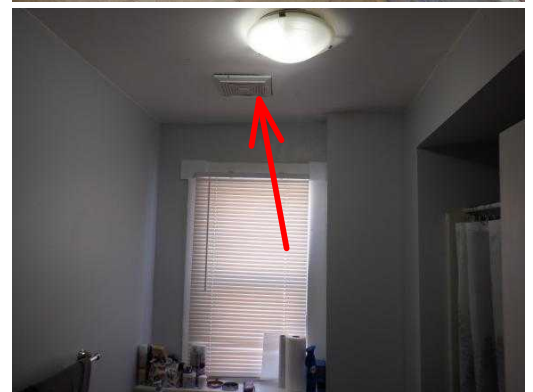
67. Second Floor - Unit 412 Bathroom Ventilation: Electric ventilation fan and window - Limited suction from fan. Cleaning or replacement may be necessary. Moisture and humidity can cause damage due to lack of ventilation in the space

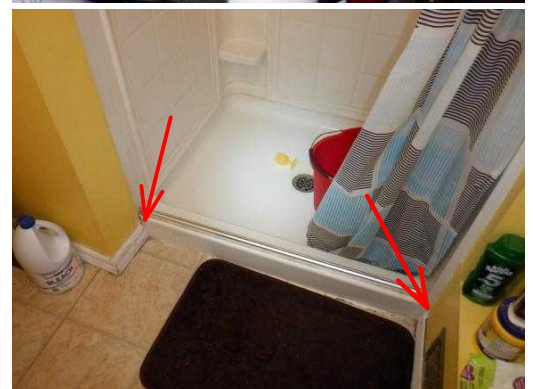
69. Second Floor - Unit 410 Bathroom Shower/Surround: Plastic pan and plastic surround - Outside corners had water signs with higher readings on the moisture meter at time of the inspection. Monitor. Caulking improvements required. Maintain caulking in this space to prevent moisture intrusion and water damage behind the wall.

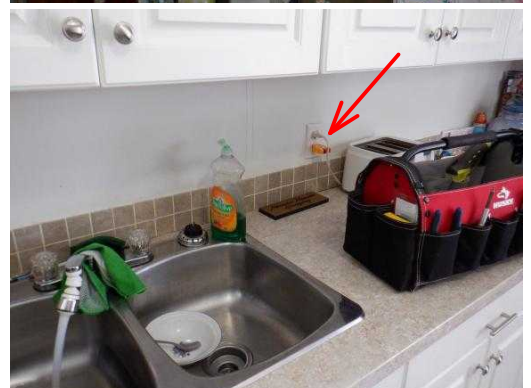
73. Main Floor Kitchen Area - 410 Kitchen Electrical: 110 - 240 VAC outlets and 110 VAC lighting circuits - Recommend installing GFCI outlets above countertop area within close proximity of the sink. Recommend repairs by a qualified electrician.

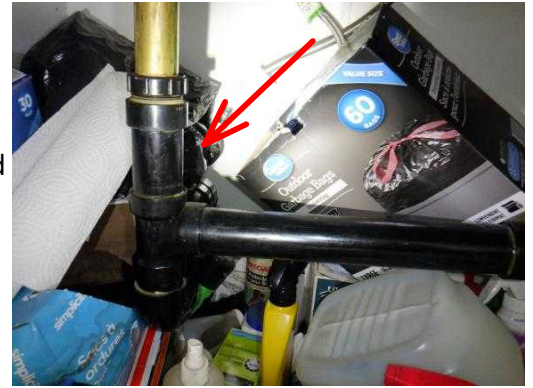
74. Main Floor Kitchen Area - 410 Kitchen Plumbing/Fixtures: Fixtures with ABS Trap - An "S" trap has been used. S traps should be replaced during any new plumbing work as they are subject to siphoning problems. Replacement is sometimes difficult and thus the S traps are usually tolerated. Care should be taken to keep the trap "primed." Fixtures should be monitored for sewer odor.

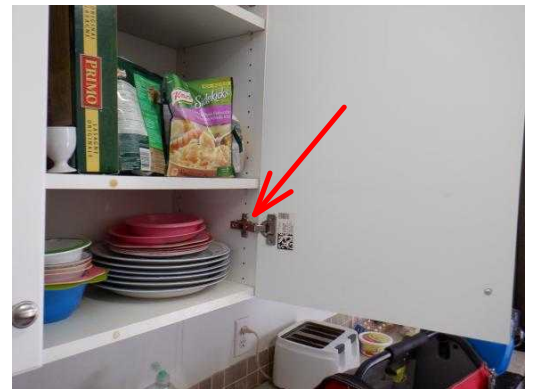
75. Main Floor Kitchen Area - 410 Kitchen Cabinets: Laminate - Damages noted. Water stains under the cabinet were dry on the moisture meter at time of the inspection. Loose cabinet doors noted. Recommend immediate repairs to prevent damage to the cabinet door or hinge.

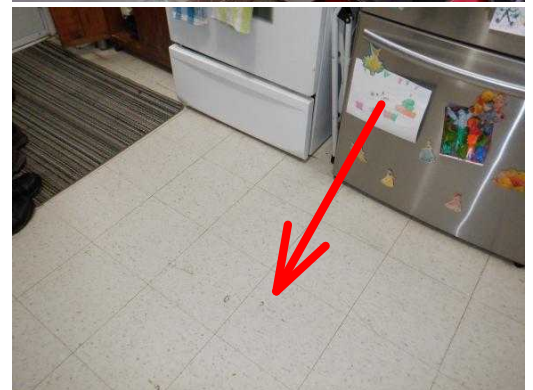
76. Main Floor Kitchen Area - 410 Kitchen Floor: Floor Tiles - Some damages and imperfections noted. These types of tiles may contain small amount of asbestos. If you are concerned we recommend testing.

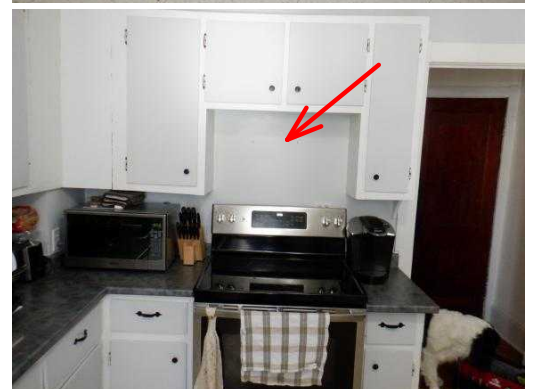
77. Main Floor Kitchen Area - 412 Kitchen Ventilator: Missing - Recommend installing a hood fan above the stove to reduce moisture and fumes in the kitchen.

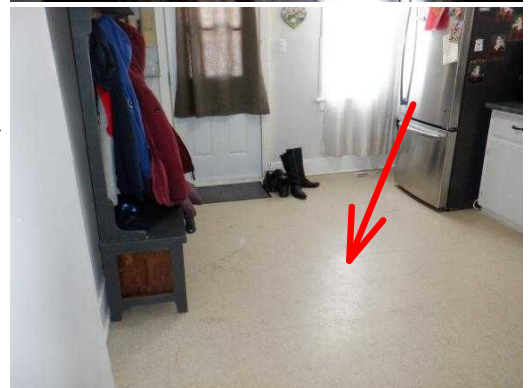
80. Main Floor Kitchen Area - 412 Kitchen Floor: Floor Tiles - Some damages and imperfections noted. These type of floor tiles have been known to contain a small amount of asbestos. However, due to the age of the home, it is unlikely unless older floor tiles were used. If you are uncomfortable with this possibility we recommend testing.

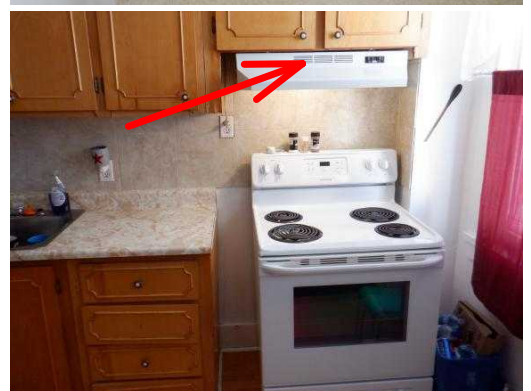
81. Main Floor Kitchen - Unit 414 Kitchen Ventilator: Electric Ventilation Fan - Fan exhaust into the kitchen. Exhaust fans should exhaust on the exterior of the building. A compromise would be using charcoal filters and change regularly.

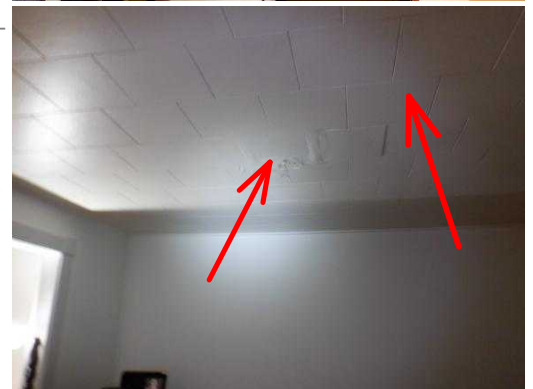
84. Living Room, Dining Area, Bedrooms, Hall and Entrance Area - 412 Living Space Ceiling: Textured, Ceiling tiles - Damage and imperfections were noted on ceiling. All oddities were dry on the moisture meter at time of the inspection. Recommend further inspection behind the finished ceiling to determine the overall extent of the past moisture concerns. These type of ceiling tiles have been known to contain a small amount of asbestos. However, due to the age of the home, it is unlikely unless older ceiling tiles were used. If you are uncomfortable with this possibility we recommend testing.

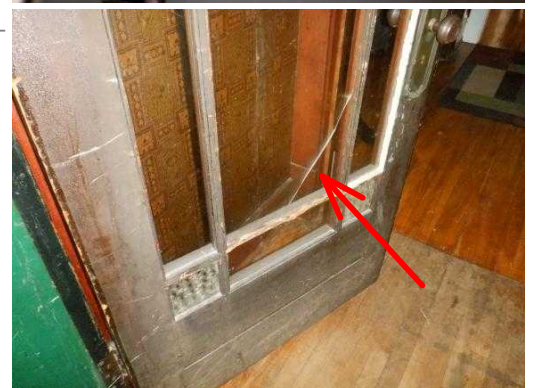
85. Living Room, Dining Area, Bedrooms, Hall and Entrance Area - 412 Living Space Doors: Hollow wood, Wood, Metal entry - Some damages and broken glass noted.

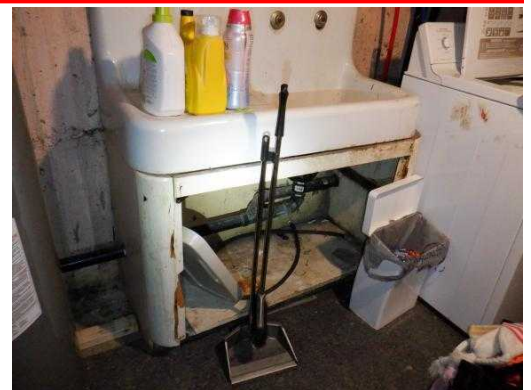
87. Building's Laundry Areas Laundry Room/Area Laundry Tub: Cast Tub - Older sink in 414 had rusting noted.

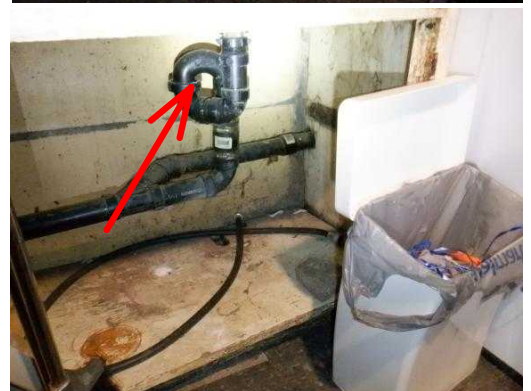
88. Building's Laundry Areas Laundry Room/Area Laundry Tub Drain: ABS Trap - An "S" trap has been used in unit 414. S traps should be replaced during any new plumbing work as they are subject to siphoning problems. Replacement is sometimes difficult and thus the S traps are usually tolerated. Care should be taken to keep the trap "primed." Fixtures should be monitored for sewer odor.

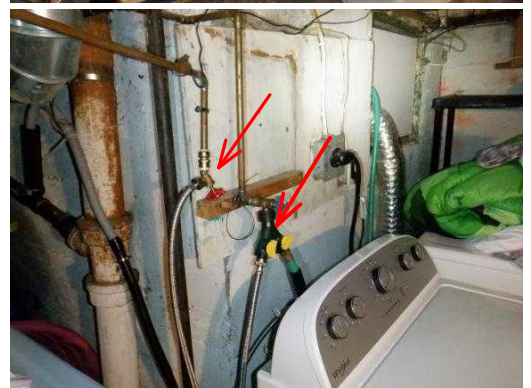
89. Building's Laundry Areas Laundry Room/Area Washer Hose Bib: Rotary - Multiple hook ups in unit 420 will reduce water pressure. Recommend improvements.

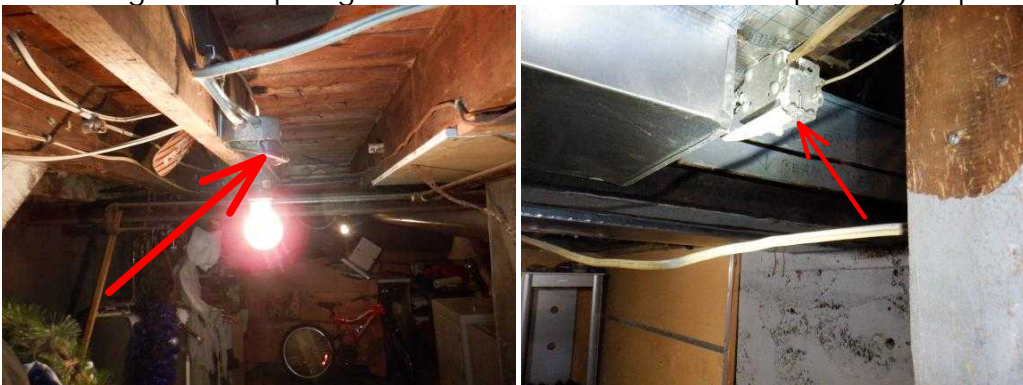
6. Entire Basement Area - Unit 416 Basement Electrical: 110 VAC Outlets and Lighting Circuits - Install missing cover plates on junction boxes, outlets and switches. Replace damaged cover plates. Loose light fixtures should be secured to prevent movement and potential wiring becoming loose. Open grounds noted. Recommend repairs by a qualified electrician.

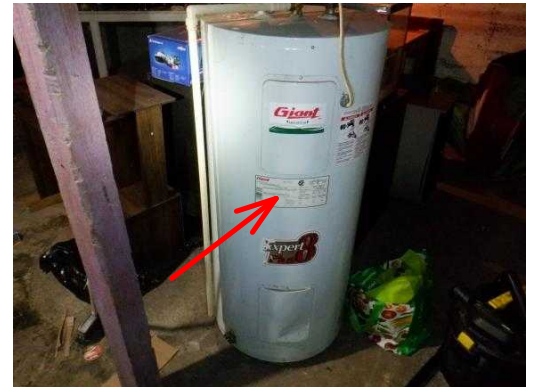
10. Basement - Unit 412 Water Heater Water Heater Operation: Functional at time of inspection - The expected life cycle for an electric hot water is 10 - 12 years. Water heater is nearing the end of it's design life (10 Years). Recommend being pro active when addressing the age of this hot water tank and not waiting for a problem.
