# Home Inspection Report

410-420 Marlborough St.  
Cornwall, Ontario K6H 4A5

Prepared for: Jared Henderson

Prepared by: Peace of Mind Home Inspections - Cornwall  
5698 County Rd. 44  
Long Sault, Ontario K0C 1P0

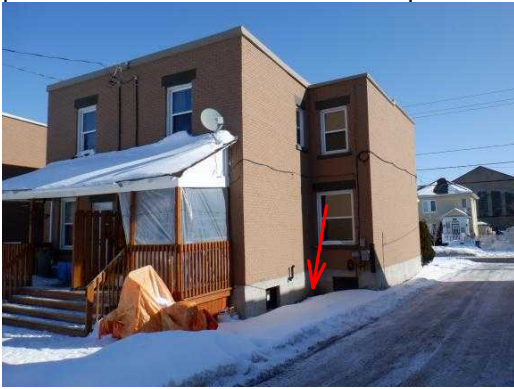
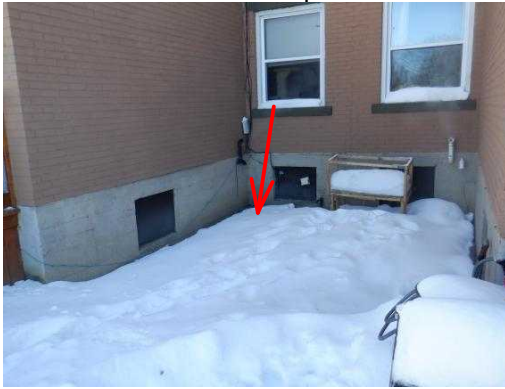
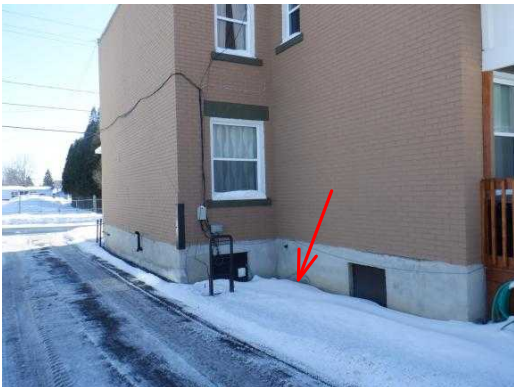
1. Grading: Snow Covered, Flat with Negative Pockets - Ground snow covered at time of inspection. Improper soil slope towards foundation in areas, recommend the addition of fill dirt to improve grade. It is very important run off water drains away from foundation to minimize chance of water leakage into the basement, as cracks in foundation walls are common. Make sure ground, patios and walkways slope away from the house for the first 6 feet (2 metres) around the perimeter of the home. Slope should be at least 1 inch per foot.

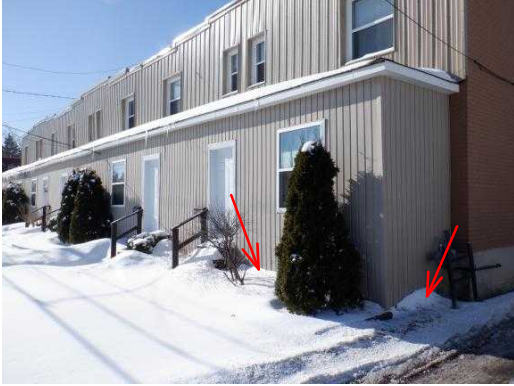
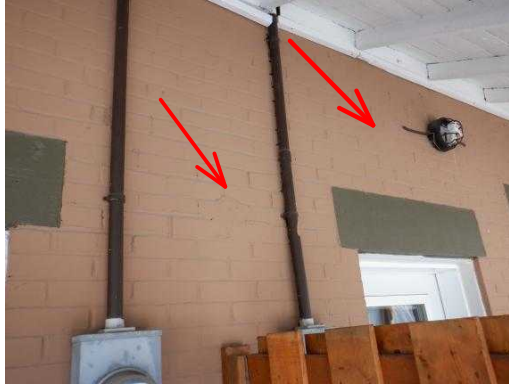
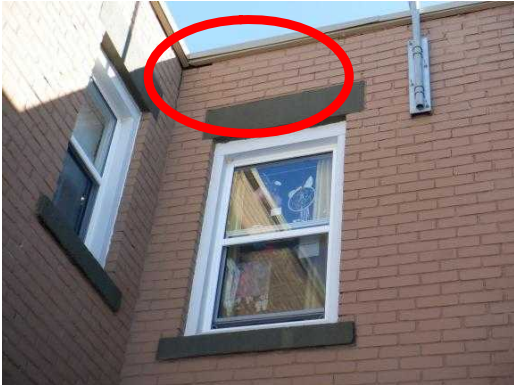
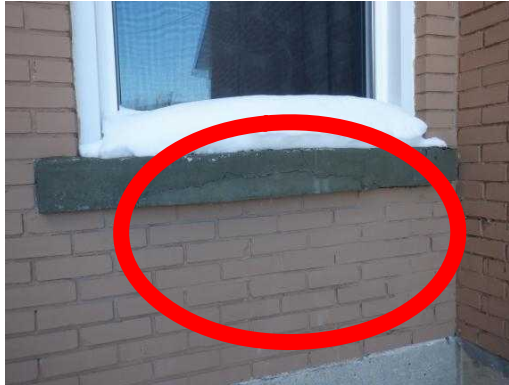
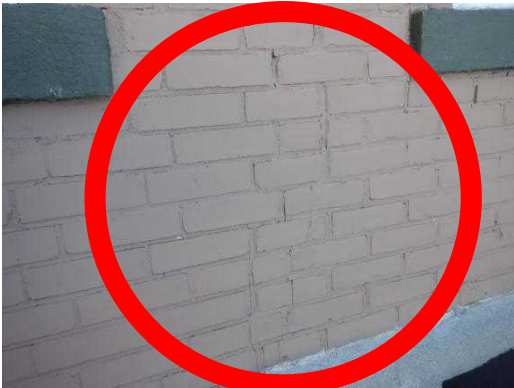
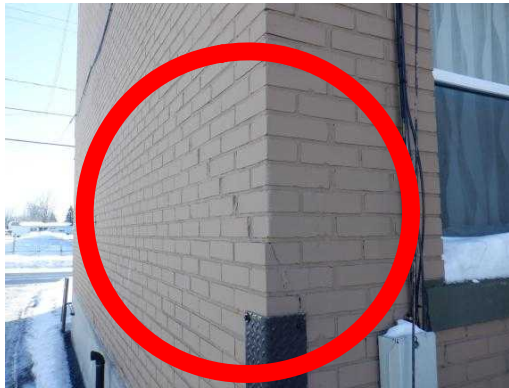
Type: (continued)

2. Walls Exterior Surface Type: Vinyl siding, Metal Siding, Brick - Minor damages and staining noted on the siding due to age. Lower elevations around building where soil is closer than 8" to underside of siding; moisture may enter structure or damage sheathing if grade is left too high. Older brick had deterioration, damages, cracking, loose/missing bricks and spalling due to age and moisture. Movement was present in areas. Previous repairs noted. Tuck and point repairs required at various locations of the building. Recommend repairs by a qualified mason. Recommend inspecting mortar between brick/stone regularly and making necessary tuck and point repairs when required to keep the integrity of the exterior and prevent moisture intrusion. Unable to view condition of the brick behind the siding.

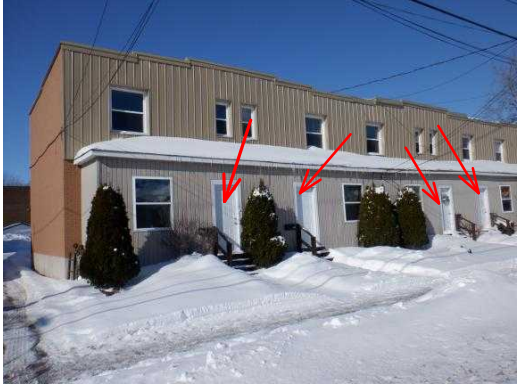
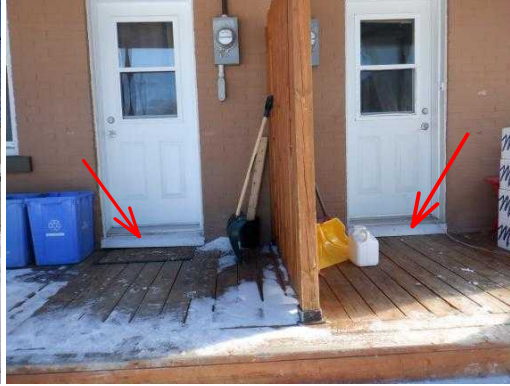
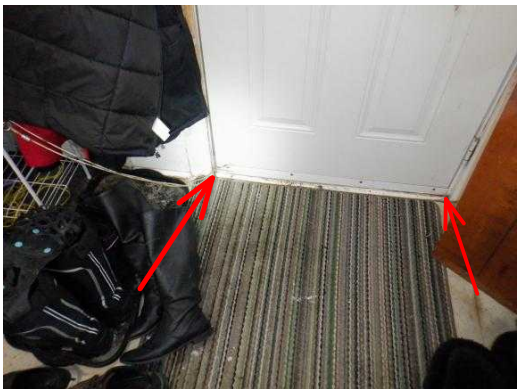
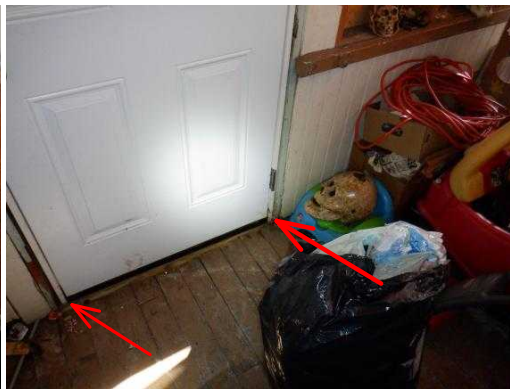
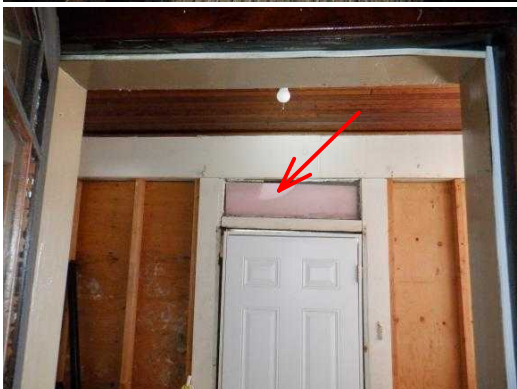
Entry Doors: (continued)

3. Entry Doors: Metal, Wood - Doors had age appropriate deterioration noted. Soft kick plate below door usually indicates deterioration and moisture damage. Caulking and seal improvements required. Recommend caulking is regularly maintained on the exterior of all door frames. Some uneven installation noted. Some doors and hardware require adjustment to facilitate operation and locking. Some inside door frames had higher readings on the moisture meter at time of the inspection. Monitor. Weather seal improvements recommend around doors. Broken terminated transom windows noted above doors.

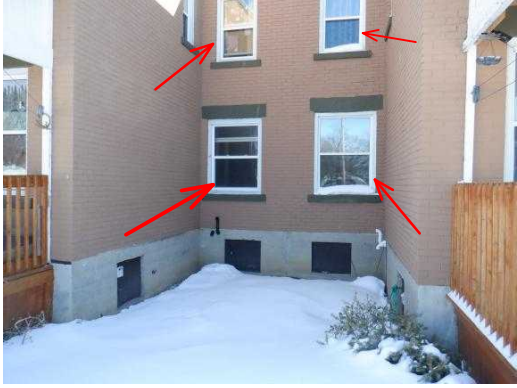
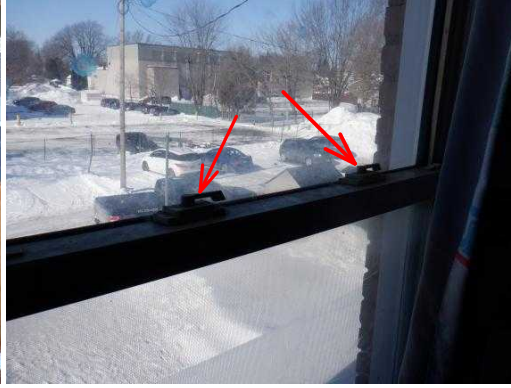
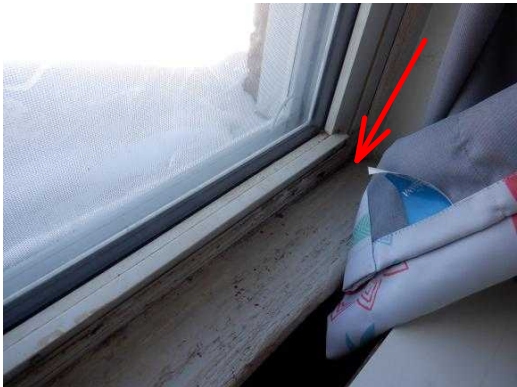
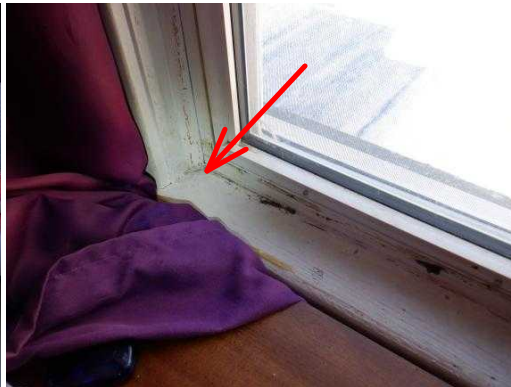
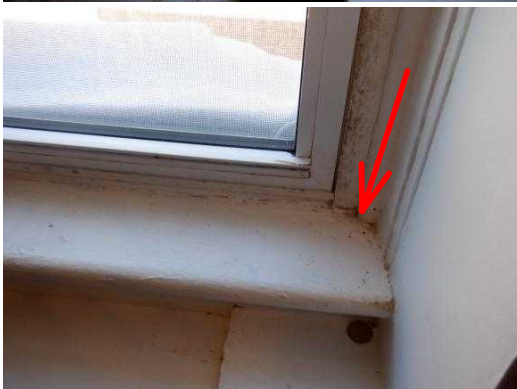
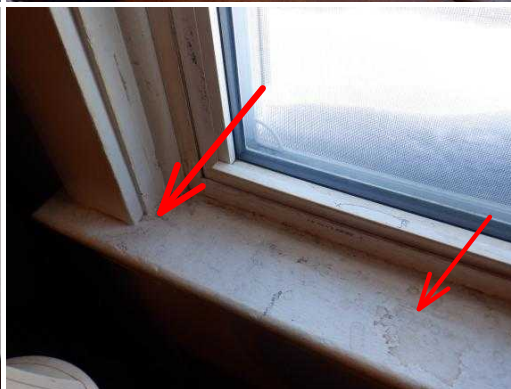
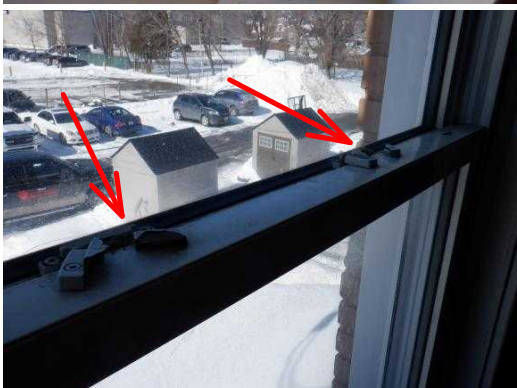
Windows: (continued)

4. Windows: Thermal Vinyl Windows - Age appropriate deterioration noted on frame portion of windows due to moisture and age. Caulking improvements required around some windows. Recommend caulking is regularly maintained on the exterior of all windows. Some windows were frozen and unable to be tested at time of the inspection. Some windows will require adjustment to facilitate ease of operation and locking. Replace damaged locking hardware. Air was noted coming through gaps between window and framing. Water stains present around windows. Some inside window frames had higher readings on the moisture meter at time of the inspection. Monitor.

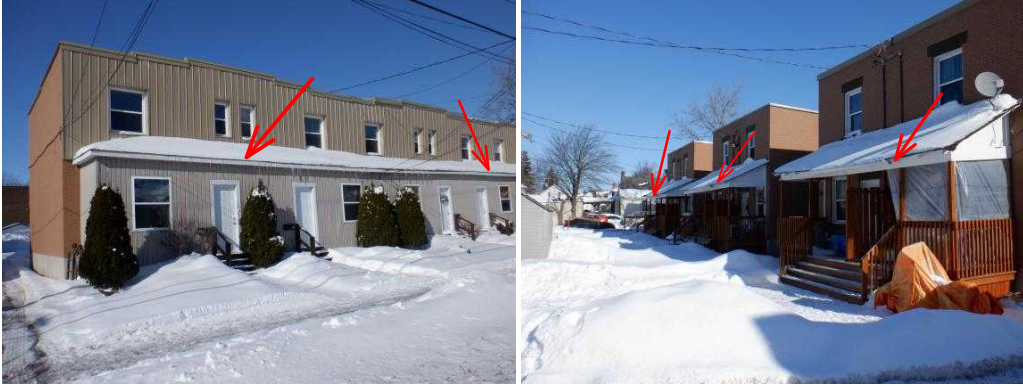
Gutters: (continued)

8. Gutters: Aluminum, Missing - Recommend installing gutters, downspouts and leaders for all eaves to prevent water from draining next to the foundation. Install missing end caps and downspouts.

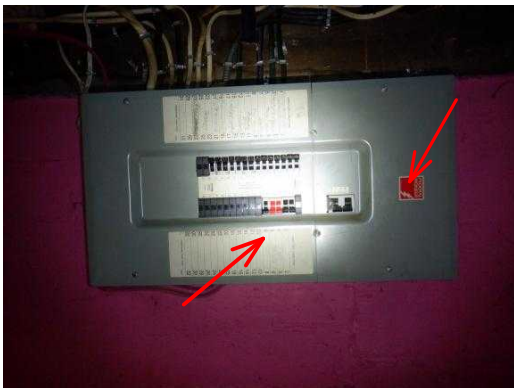
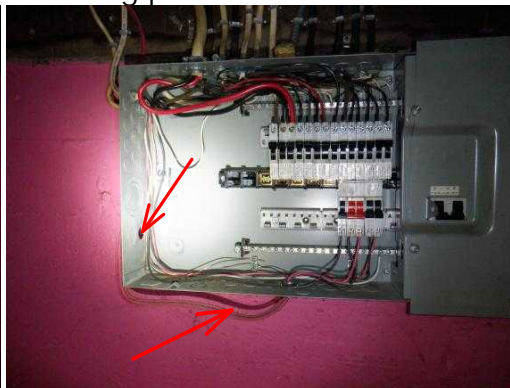
14. Basement - Service and Distribution Panel - Unit 418 Electric Panel Manufacturer: Federal Pioneer Stab lok - Panel was not clearly labeled. Recommend labeling each breaker clearly and accurately. Note: Federal Pioneer Stab Lok panels are discontinued. The breakers will be difficult to find and will likely be expensive. These type of panels have a history of not tripping. The rarity of the breakers will lead to these panels having to be updated in the future. Open "knock-out" hole- insert "blank-out" cap to close off opening. Loose wiring at panel. Wiring should be secured within 12 inches of exiting panel.

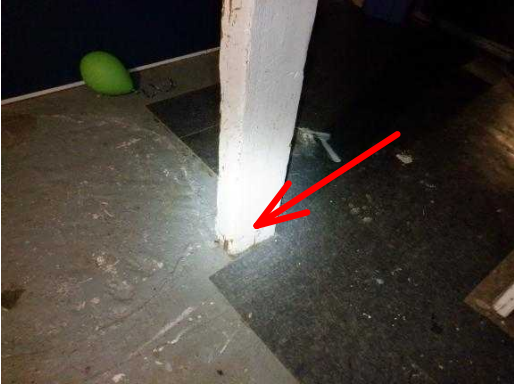
Piers/Posts: (continued)

18. Piers/Posts: Wood posts - Some Footings/Piers were not visible but standard construction is generally below the concrete floor. Deterioration was noted on older wood posts with some moisture damage present at the bases. Minor movement noted. Posts should be upgraded in the future.

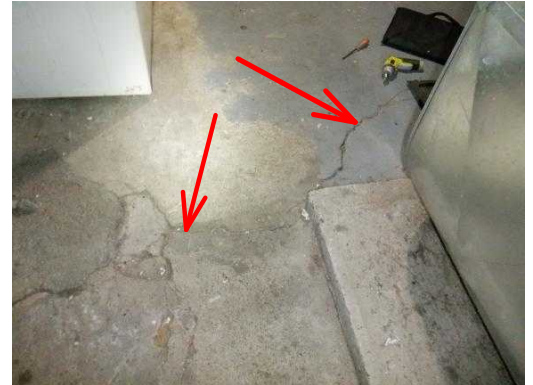
19. Floor/Slab: Concrete - Some portions of the floor were not visible due to floor coverings. Deterioration and cracking present at time of the inspection. Shrinkage cracking noted in areas with minor separation noted. Recommend sealing the cracks to prevent efflorescence.

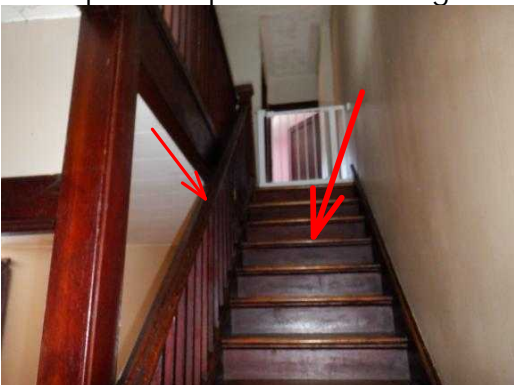
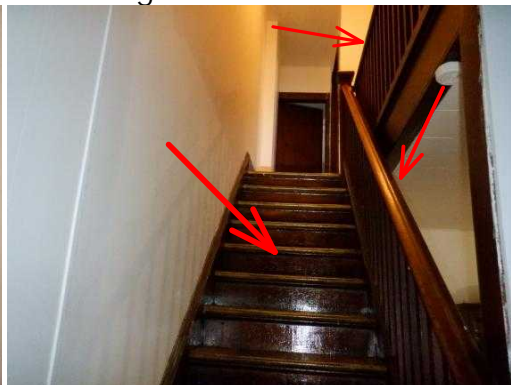
20. Stairs/Handrails: Wood stairs with wood handrails - Settlement on the stairs were comparable to the rest of the home. Loose, deteriorated and soft steps require improvements. Some railing system height is low and does not meet today's safety standards. Secure loose railings for safety and to prevent potential damage to the railings.

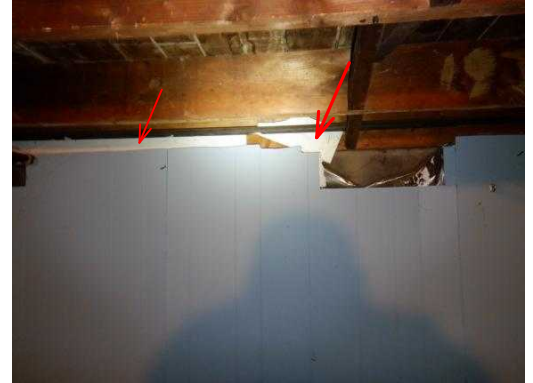
23. Entire Basement Area - Unit 410 Basement Insulation: Polystyrene - Unable to inspect portions covered by wall finishes. Recommend removal or covering of polystyrene insulation with a fire retardant like drywall as it is extremely flammable and the gases are toxic.

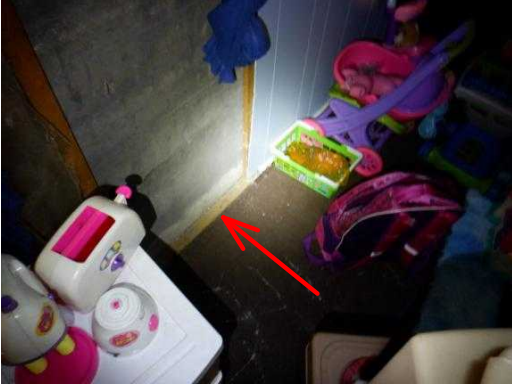
Moisture Location: (continued)

24. Entire Basement Area - Unit 410 Basement Moisture Location: Moisture signs in the basement area. Water stains present. Efflorescence noted on basement walls from past moisture. Ongoing seepage present. These older basements will always likely have some leakage and should be cared for with this in mind. There are signs of previous water penetration. Recommend referring to the seller to determine the extent of previous basement moisture. Musty odors and dampness was noted throughout the basement area. A dehumidifier and improved air circulation are recommended to reduce potential condensation problems in the basement. No moisture barrier was present under the partition walls and concrete floor. This situation will allow for dampness from the concrete to enter the wood.

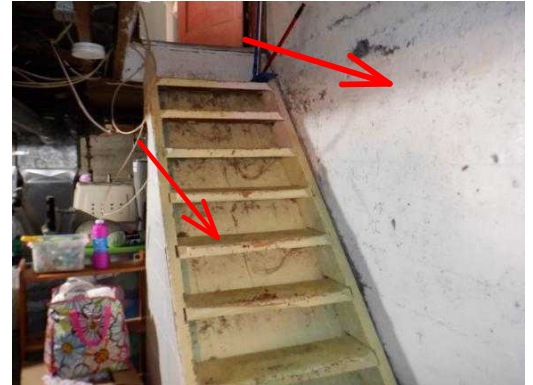
25. Entire Basement Area - Unit 410 Basement Stairs/Railings: Wood stairs with no handrails - Deteriorated older steps require improvements. Install missing railing. As with the case of most older homes the basement stairs have limited clearances and/or don't meet today's standards. Caution should be used at all times when using the stairs for safety.

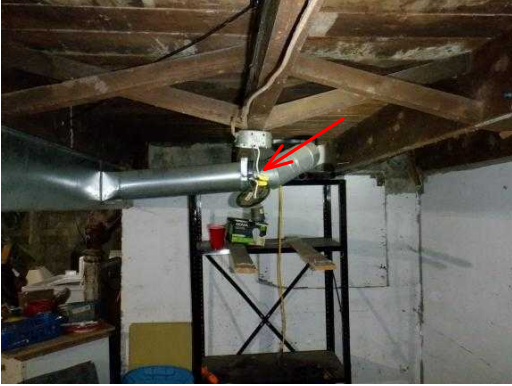
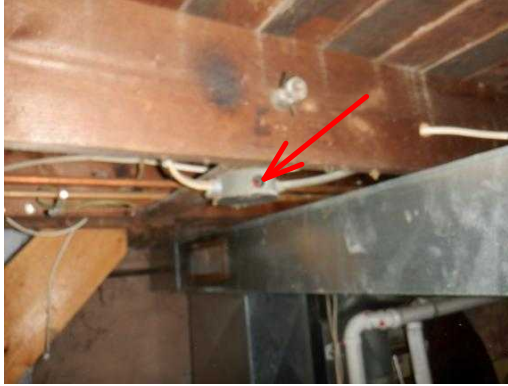
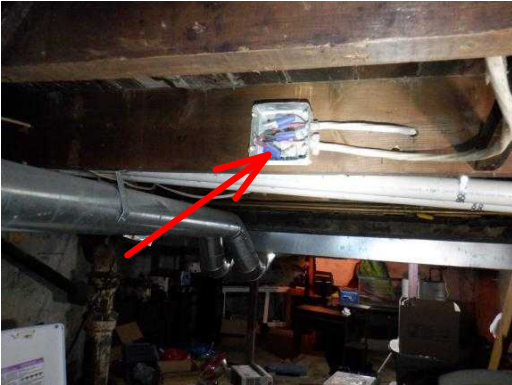
Electrical: (continued)

26. Entire Basement Area - Unit 412 Basement Electrical: 110 VAC Outlets and Lighting Circuits - Loose fixtures should be secured to prevent movement and potential wiring becoming loose. Open "knock-out" hole- insert "blank-out" cap to close off opening. Install missing junction box cover plates.

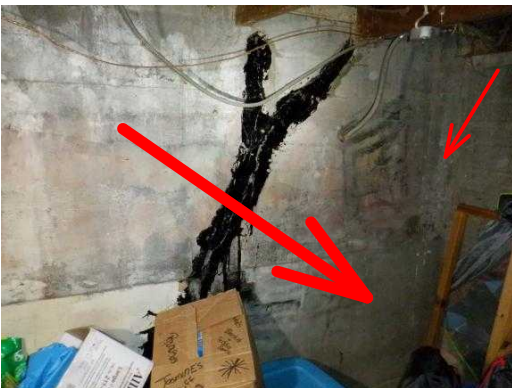
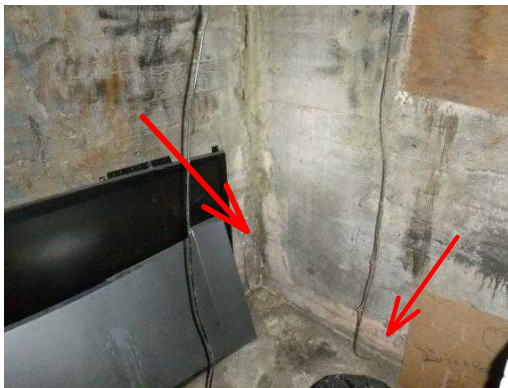
27. Entire Basement Area - Unit 412 Basement Moisture Location: Moisture signs in the basement area. Water stains present. Efflorescence noted on basement walls from past moisture. Ongoing seepage present. These older basements will always likely have some leakage and should be cared for with this in mind. There are signs of previous water penetration. Recommend referring to the seller to determine the extent of previous basement moisture. Musty odors and dampness was noted throughout the basement area. A dehumidifier and improved air circulation are recommended to reduce potential condensation problems in the basement. No moisture barrier was present under the partition walls and concrete floor. This situation will allow for dampness from the concrete to enter the wood.

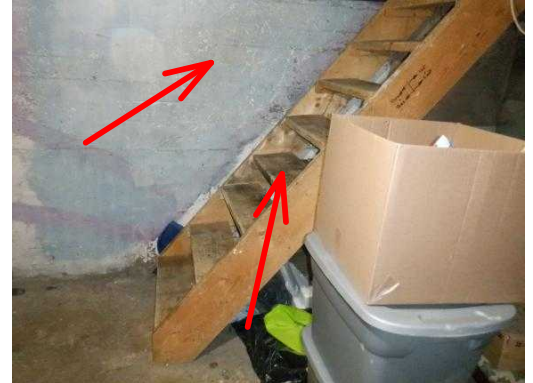
28. Entire Basement Area - Unit 412 Basement Basement Stairs/Railings: Wood stairs with no handrails - Deteriorated older steps require improvements. Install missing railing. As with the case of most older homes the basement stairs have limited clearances and/or don't meet today's standards. Caution should be used at all times when using the stairs for safety.

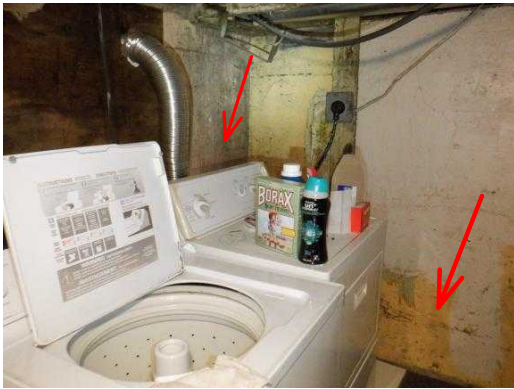
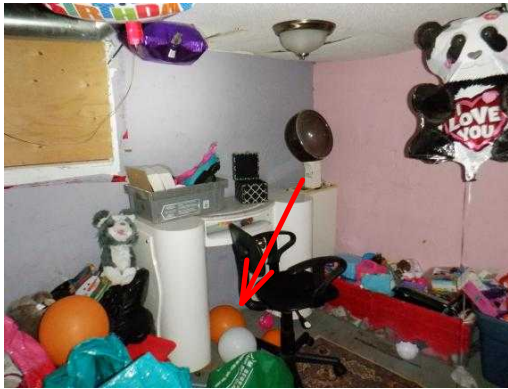
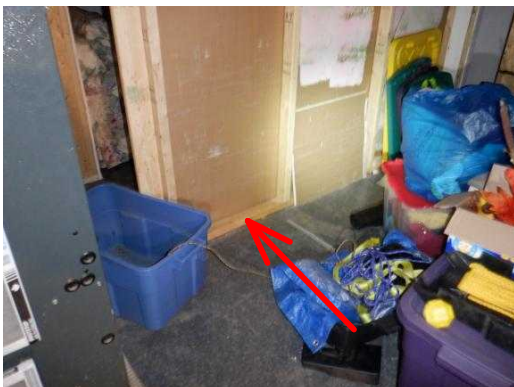
29. Entire Basement Area - Unit 414 Basement Moisture Location: Moisture signs in the basement area. Water stains present. Efflorescence noted on basement walls from past moisture. These older basements will always likely have some leakage and should be cared for with this in mind. There are signs of previous water penetration. Recommend referring to the seller to determine the extent of previous basement moisture. Musty odors and dampness was noted throughout the basement area. A dehumidifier and improved air circulation are recommended to reduce potential condensation problems in the basement. No moisture barrier was present under the partition walls and concrete floor. This situation will allow for dampness from the concrete to enter the wood.

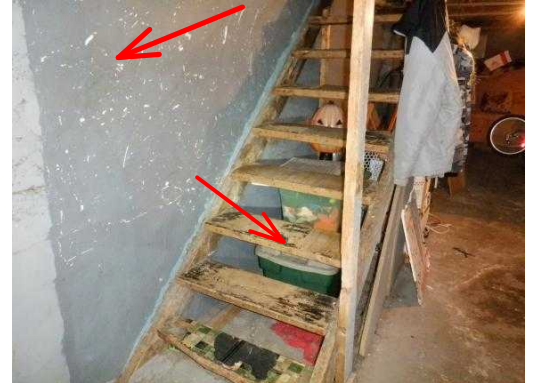
33. Entire Basement Area - Unit 416 Basement Basement Stairs/Railings: Wood stairs with no handrails - Deteriorated older steps require improvements. Install missing railings. As with the case of most older homes the basement stairs have limited clearances and/or don't meet today's standards. Caution should be used at all times when using the stairs for safety.

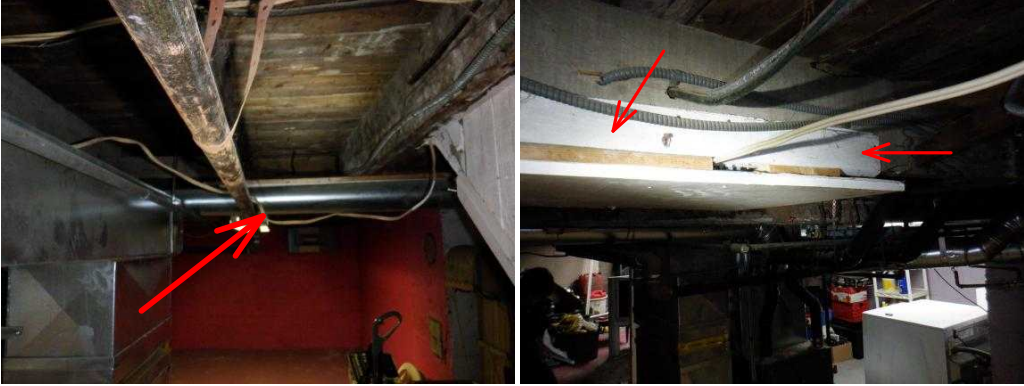
40. Basement Unit 418 Heating System Distribution: Metal duct - Majority of duct work was not visible due to interior finishings. Insulation required between duct work and wiring to prevent over heating of the wiring. Suspected asbestos present. Recommend testing and removal by a qualified contractor.

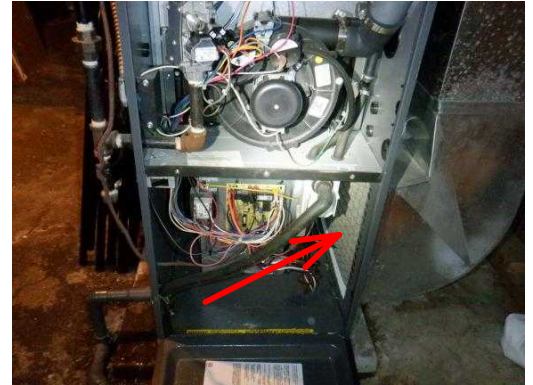
41. Basement Unit 416 Heating System Blower Fan/Filter: Drive with disposable filter - Filter is dirty. Change filter regularly

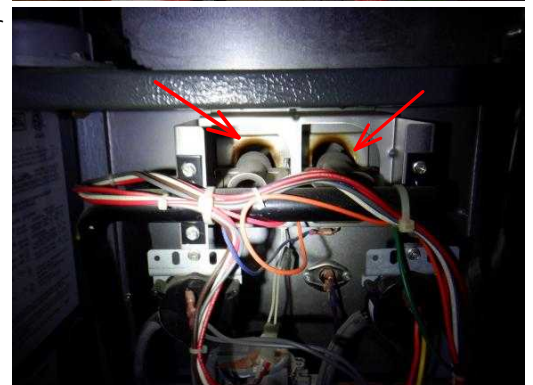
43. Basement Unit 414 Heating System Heat Exchanger: 2 Burner - The heat exchanger is substantially concealed and could not be fully inspected. Advanced deterioration was noted on older burners due to age but no cracks were visible at time of the inspection.

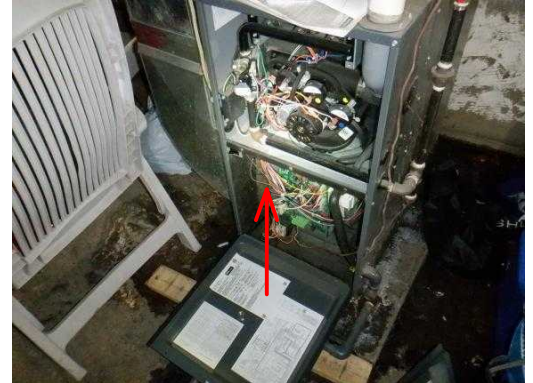
48. Basement Unit 412 Heating System Blower Fan/Filter: Drive with disposable filter - Filter is dirty. Change filter regularly. Recommend using better quality filters.

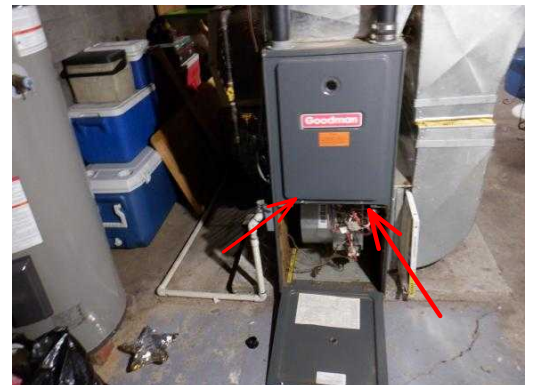
50. Basement Unit 410 Heating System Heating System Operation: Functional at time of the inspection - Unable to fully open and the inspect the furnace due to stripped cover screws. Replace stripped cover screws. Life expectancy of a high efficiency furnace is 15 - 20 years. Service and cleaning recommended on an annual basis to ensure proper function and to prolong the stated design life of the unit.

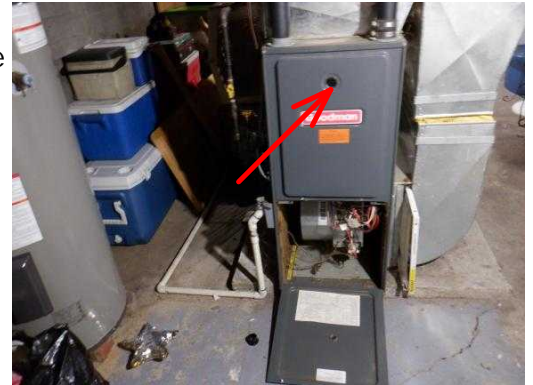
51. Basement Unit 410 Heating System Heat Exchanger: Burner - The heat exchanger is substantially concealed and could not be fully inspected. Improper flame color indicates less than perfect efficiency of the unit. This should be inspected by your heating contractor during your next cleaning.

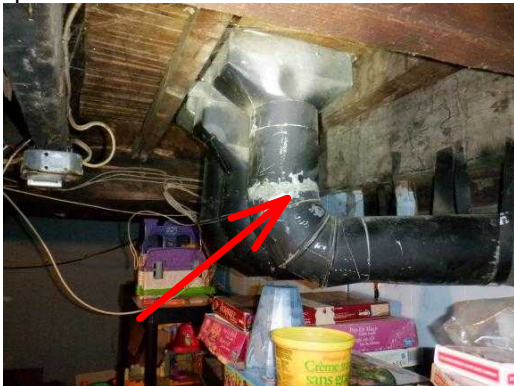
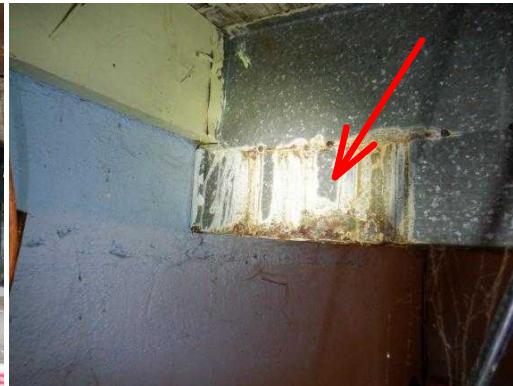
53. Basement Unit 410 Heating System Distribution: Metal duct - Some duct work was not visible due to interior finishings. Ducts were dirty and in need of a cleaning. Rusting and deterioration was present on older ducts but no penetrations were noted. Recommend using proper aluminum tape to seal all duct connections and terminations.

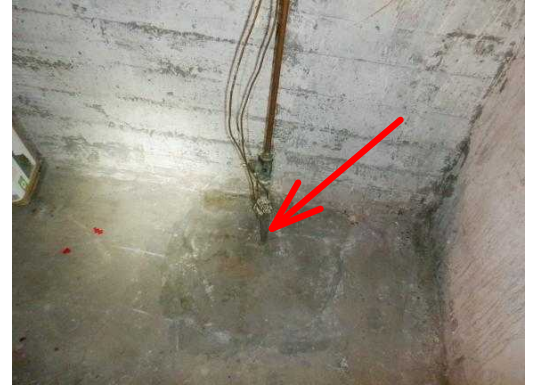
54. Service Line: Visible portions were copper - Diameter of some service lines were smaller than today's standards due to the age of the home. Tenants reported poor water pressure on upper levels when other faucets are being used.

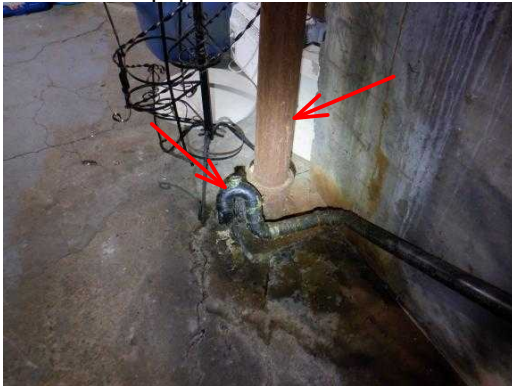
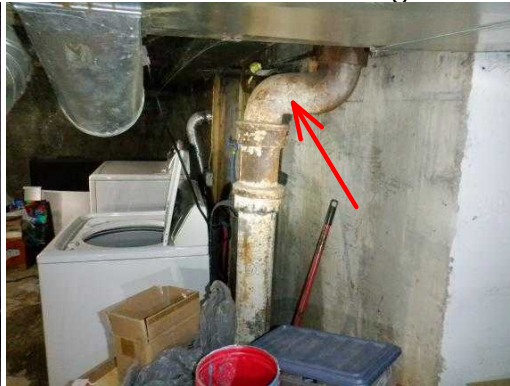
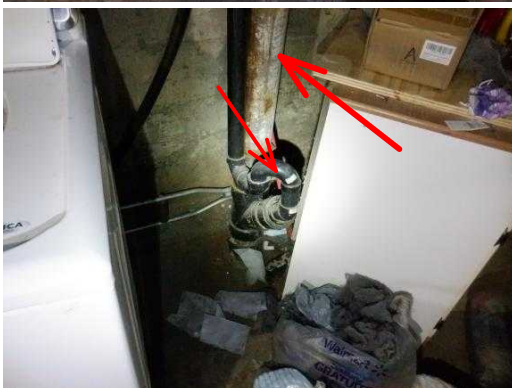
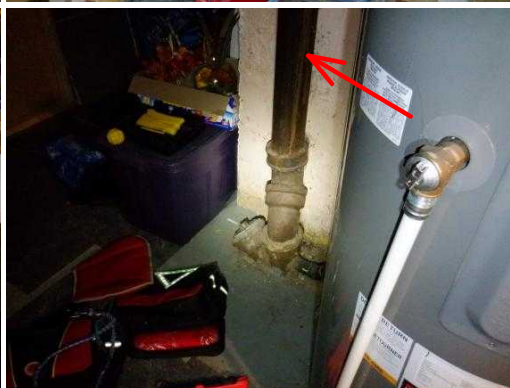
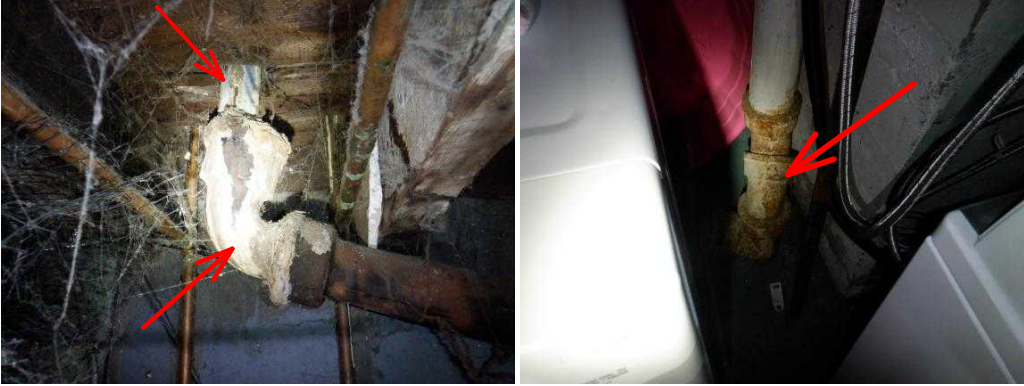
55. Drain Pipes: All visible drain pipes were ABS, Copper, Cast iron, Galvanized - Some drain piping was not visible due to interior finishing. Pitting and rusting noted on older cast drain piping. No leakage was present at time of the inspection. Monitor. An "S" trap has been used. S traps should be replaced during any new plumbing work as they are subject to siphoning problems. Replacement is sometimes difficult and thus the S traps are usually tolerated. Care should be taken to keep the trap "primed." Fixtures should be monitored for sewer odor. Some visible galvanized drain pipes were terminated. Galvanized pipe present in unit 416 but appeared to be just a vent pipe but this could not be confirmed due to finishings. Owner may have insight.

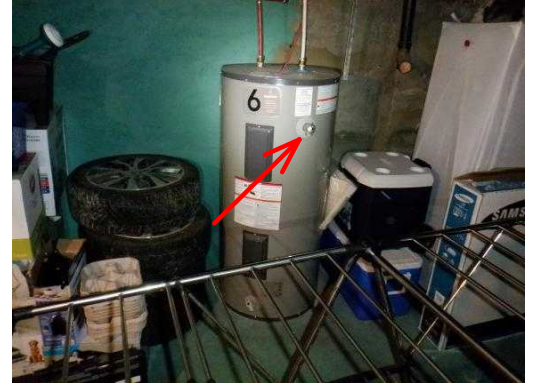
58. Basement - Unit 220 Water Heater TPRV and Drain Tube: Copper valve and missing tube - This safety valve cannot be tested during this inspection. For safety reasons, and to prevent potential scalding, the water heater temperature setting should not be above 120 degrees. The hot water temperature should be checked immediately upon moving in. Install missing TPRV tube

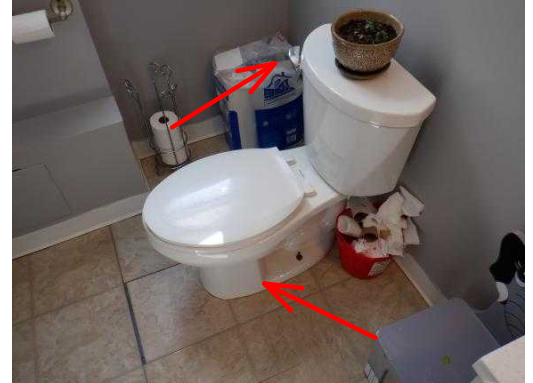
62. Second Floor - Unit 414 Bathroom Toilets: American Standard  
- The toilet is loose at the floor and will require tightening along with the possibility of replacing of the wax seal. Flush hardware requires adjustment.

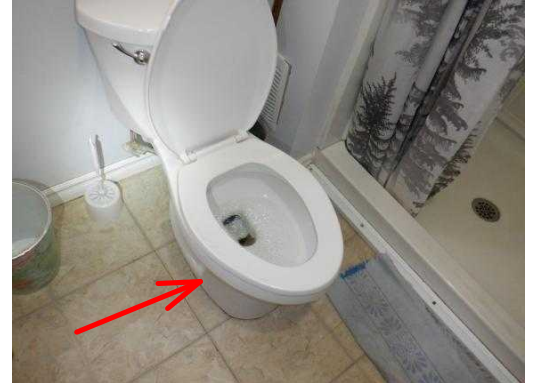
66. Second Floor - Unit 412 Bathroom Toilets: American Standard  
- The toilet is loose at the floor and will require tightening along with the possibility of replacing of the wax seal.

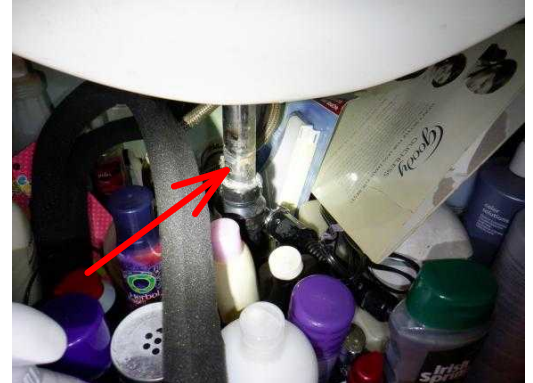
68. Second Floor - Unit 410 Bathroom Faucets/Traps: Fixtures with ABS Trap - Some corrosion was noted on the drain but no leakage was present at time of the inspection. Monitor.

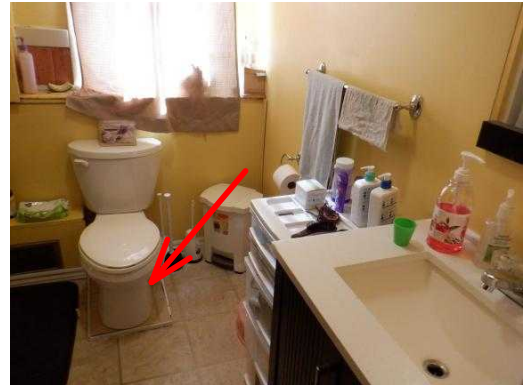
70. Second Floor - Unit 410 Bathroom Toilets: American Standard - Moisture stains noted around base of toilet. It appeared to be as urine. Monitor. Toilet does not flush properly. Recommend improvements.

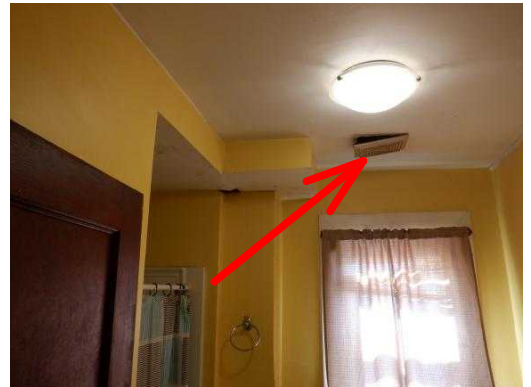
71. Second Floor - Unit 410 Bathroom Ventilation: Electric ventilation fan and window - Limited suction from older fan. Cleaning or replacement may be necessary. Moisture and humidity can cause damage due to lack of ventilation in the space

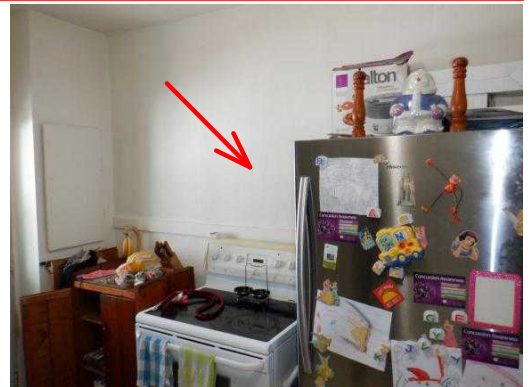
72. Main Floor Kitchen Area - 410 Kitchen Ventilator: Missing - Recommend installing a hood fan above the stove to reduce moisture and fumes in the kitchen.

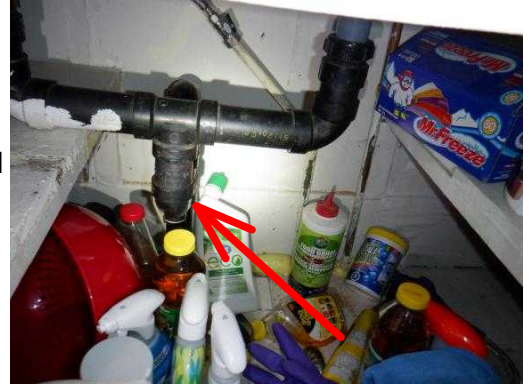
78. Main Floor Kitchen Area - 412 Kitchen Plumbing/Fixtures: Fixtures with ABS Trap - An "S" trap has been used. S traps should be replaced during any new plumbing work as they are subject to siphoning problems. Replacement is sometimes difficult and thus the S traps are usually tolerated. Care should be taken to keep the trap "primed." Fixtures should be monitored for sewer odor.

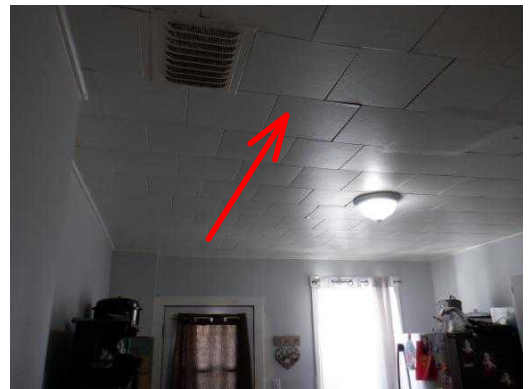
79. Main Floor Kitchen Area - 412 Kitchen Ceiling: Ceiling tiles - Damage and imperfections were noted on ceiling. All oddities were dry on the moisture meter at time of the inspection. These type of ceiling tiles have been known to contain a small amount of asbestos. If you are uncomfortable with this possibility we recommend testing.

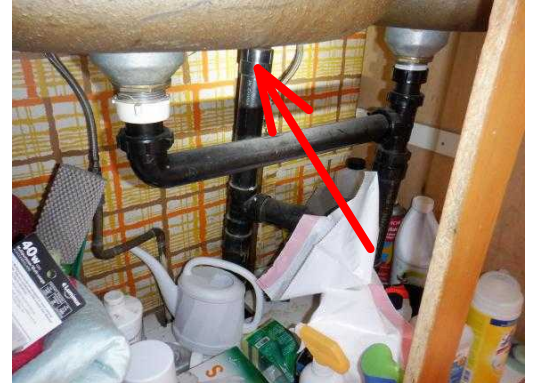
82. Main Floor Kitchen - Unit 414 Kitchen Plumbing/Fixtures: Fixtures with ABS Trap - Some areas do not appear to be vented. Installing power vents would be a reasonable inexpensive solution. A licensed plumber is recommended to evaluate and estimate repairs.

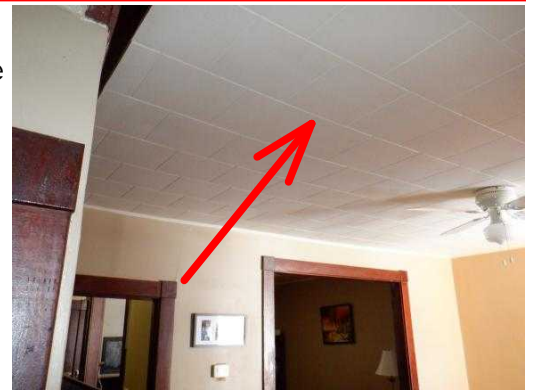
83. Living Room, Dining Area, Bedrooms, Hall and Entrance - Unit 410 Living Space Ceiling: Textured, Ceiling tiles - Damage and imperfections were noted on ceiling. All oddities were dry on the moisture meter at time of the inspection. These type of ceiling tiles have been known to contain a small amount of asbestos. If you are uncomfortable with this possibility we recommend testing.

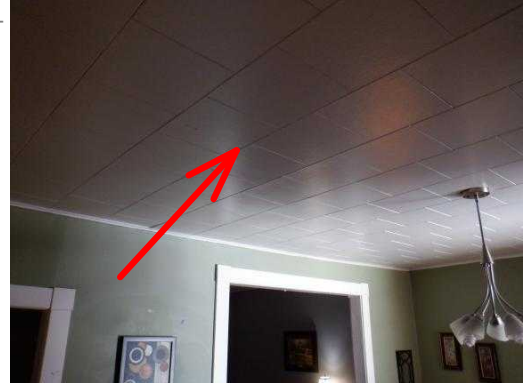
86. Living Room, Dining Area, Bedrooms, Hall and Entrance Area - Unit 414 Living Space Ceiling: Textured, Drywall and Paint, Ceiling tiles - Damage and imperfections were noted on ceiling. Settlement cracks noted at various locations of the ceiling. All oddities were dry on the moisture meter at time of the inspection. These type of ceiling tiles have been known to contain a small amount of asbestos. If you are uncomfortable with this possibility we recommend testing.

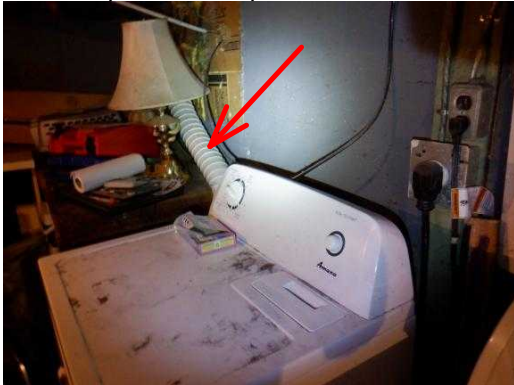
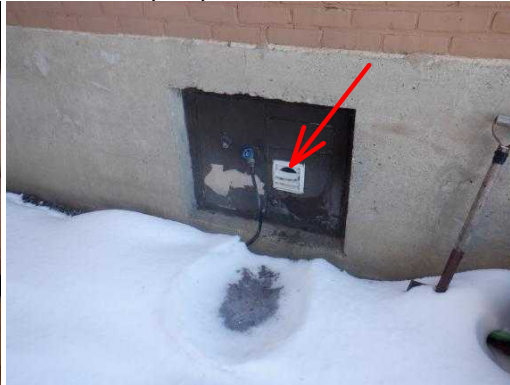
90. Building's Laundry Areas Laundry Room/Area Dryer Vent: Visible Portion Was Metal Flex, Plastic flex - Replace plastic flex in unit 416 with metal flex for safety reasons. For safety reasons, the dryer exhaust duct should always discharge directly to the exterior of the structure. Lint accumulation in a dryer duct poses a potential fire hazard. To prevent lint accumulation, the use of flexible metal duct should be limited to the connection of the dryer to the adjacent rigid metal duct and the dryer duct should be cleaned and inspected on a regular basis. Plastic flex should never be used as it's known to be a fire hazard. Replace broken exterior dryer vent cover to prevent potential pest intrusion and allow for proper ventilation of the dryer.

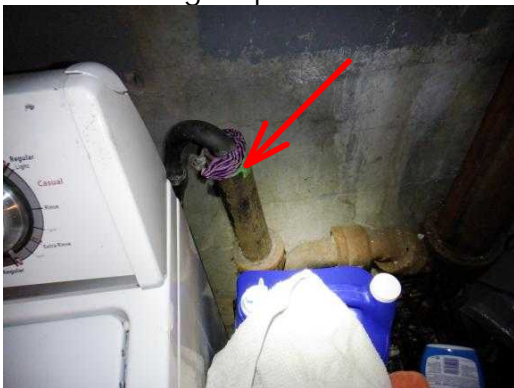
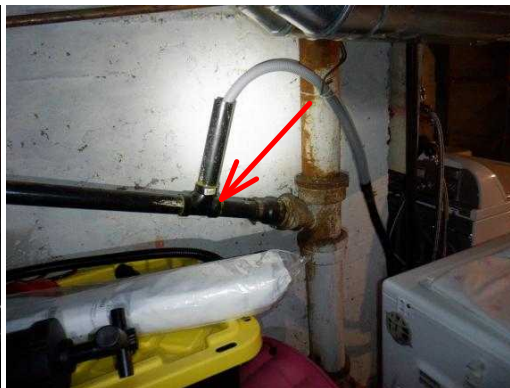
91. Building's Laundry Areas Laundry Room/Area Washer Drain: Drains to main drain system - Washing machine drain tail pipe should be a minimum 24 inches in length with 2 inch diameter and above the flood rim of the sink/washing machine. Recommend improvements in unit 416. Install missing trap in unit 420.

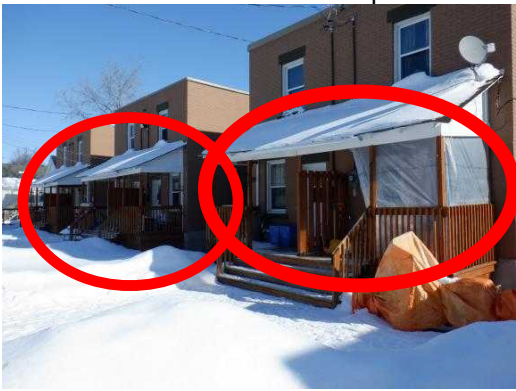
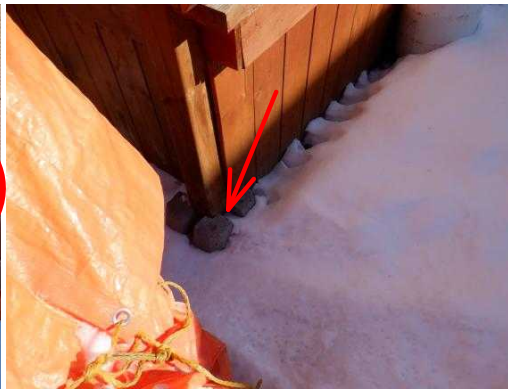
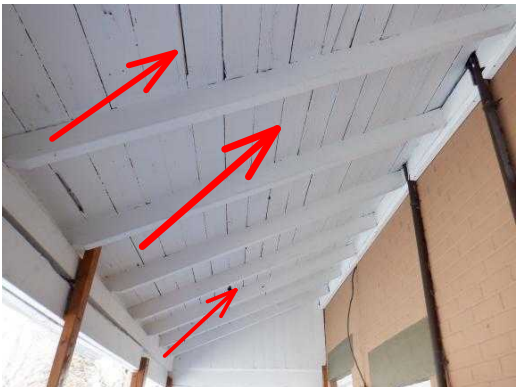
1. Steps/Stoops: Wood Frame Rear Stoops - Stoops built without access, unable to inspect underside. However, improper footings noted. Settlement was present on the rear structures and roofs. Older wood had deterioration present. Roofs were almost fully snow covered at time of the inspection but small visible areas had deterioration and curling noted. Roof sheathing was visible at the eaves with extreme deterioration noted. A qualified contractor is recommended to evaluate and estimate repairs.

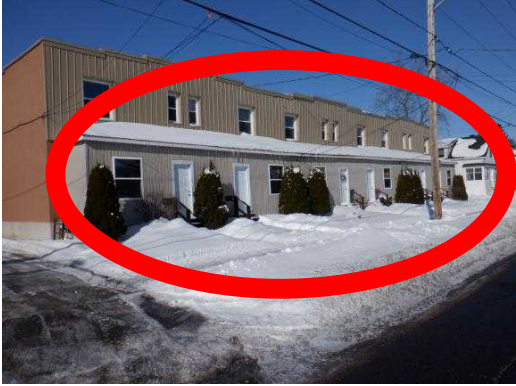
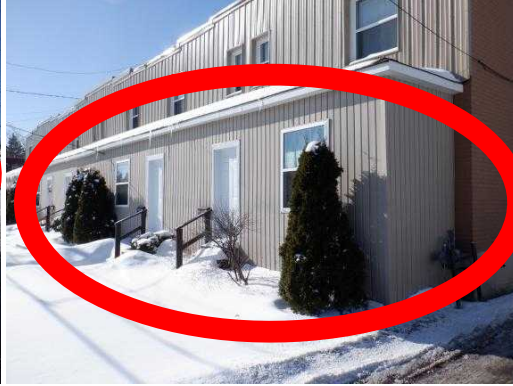
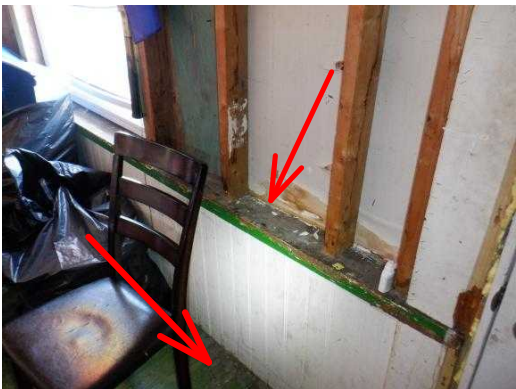
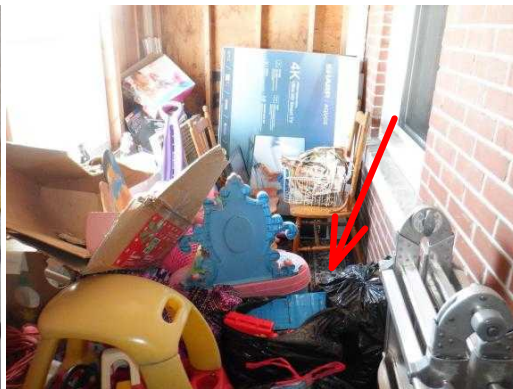
2. Porch: Wood Frame Front Porches - Porches built without access, unable to inspect the underside. Extensive settlement and sagging was present on the front wood structures. Roofs were almost fully snow covered at time of the inspection but small visible areas had deterioration and curling noted. Outside walls had water damage noted. A qualified contractor is recommended to evaluate and estimate repairs

4. Defective Porch: Wood Frame Front Porches - Porches built without access, unable to inspect the underside. Extensive settlement and sagging was present on the front wood structures. Roofs were almost fully snow covered at time of the inspection but small visible areas had deterioration and curling noted. Outside walls had water damage noted. A qualified contractor is recommended to evaluate and estimate repairs

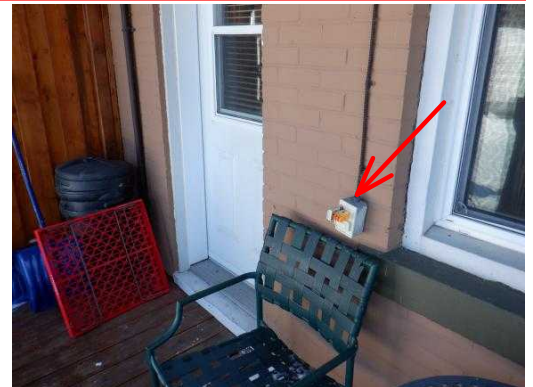
3. Exterior Electric Outlets: 110 VAC - Non-GFCI outlet was not functional at time of the inspection. Recommend all exterior outlets are ground fault protected. Loose outlet should be secured to prevent movement and potential wiring becoming loose. Recommend improvement by a qualified electrician.

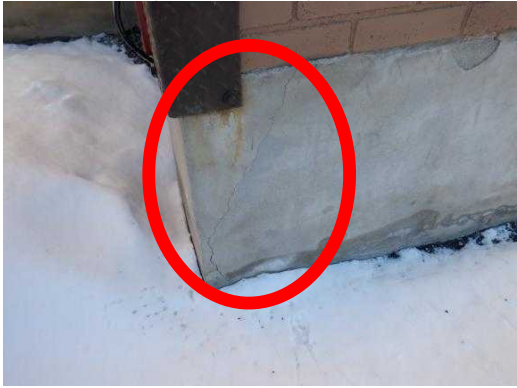
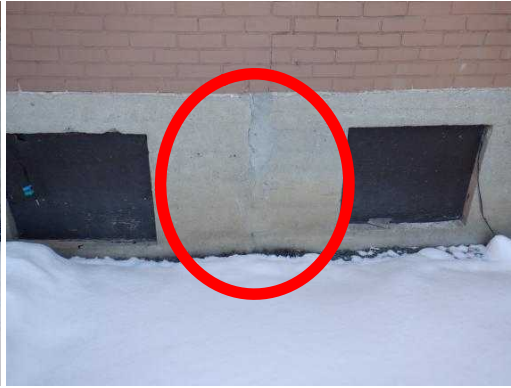
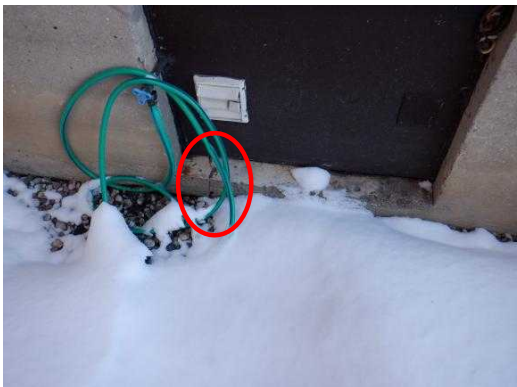
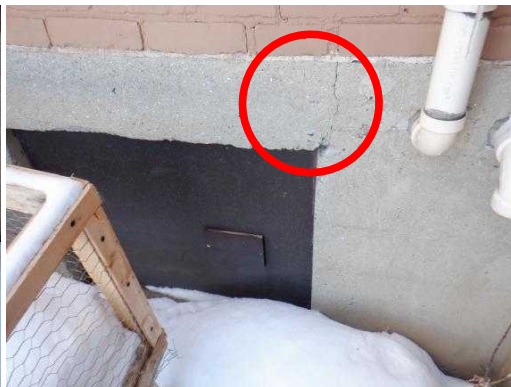
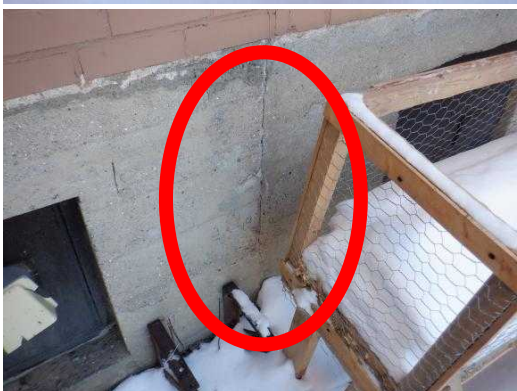
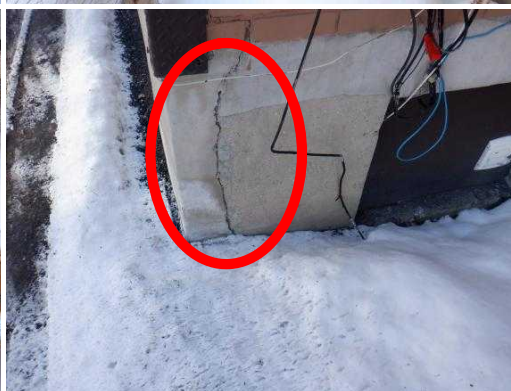
4. Foundation: Visible Portion Was Concrete - Portions of the foundation on the interior of the building was not visible due to finished wall coverings. Previous foundation repairs noted. Owner may have insight to extent of the repairs and if any warranty covers the repairs. Cracks will require monitoring, if movement or moisture entry noted, recommend epoxy injection be performed. Larger cracks with displacement should be addressed immediately. Recommend repairs by a qualified foundation contractor.
