# Home Inspection Report

410-420 Marlborough St.  
Cornwall, Ontario K6H 4A5

Prepared for: Jared Henderson

Prepared by: Peace of Mind Home Inspections - Cornwall  
5698 County Rd. 44  
Long Sault, Ontario K0C 1P0

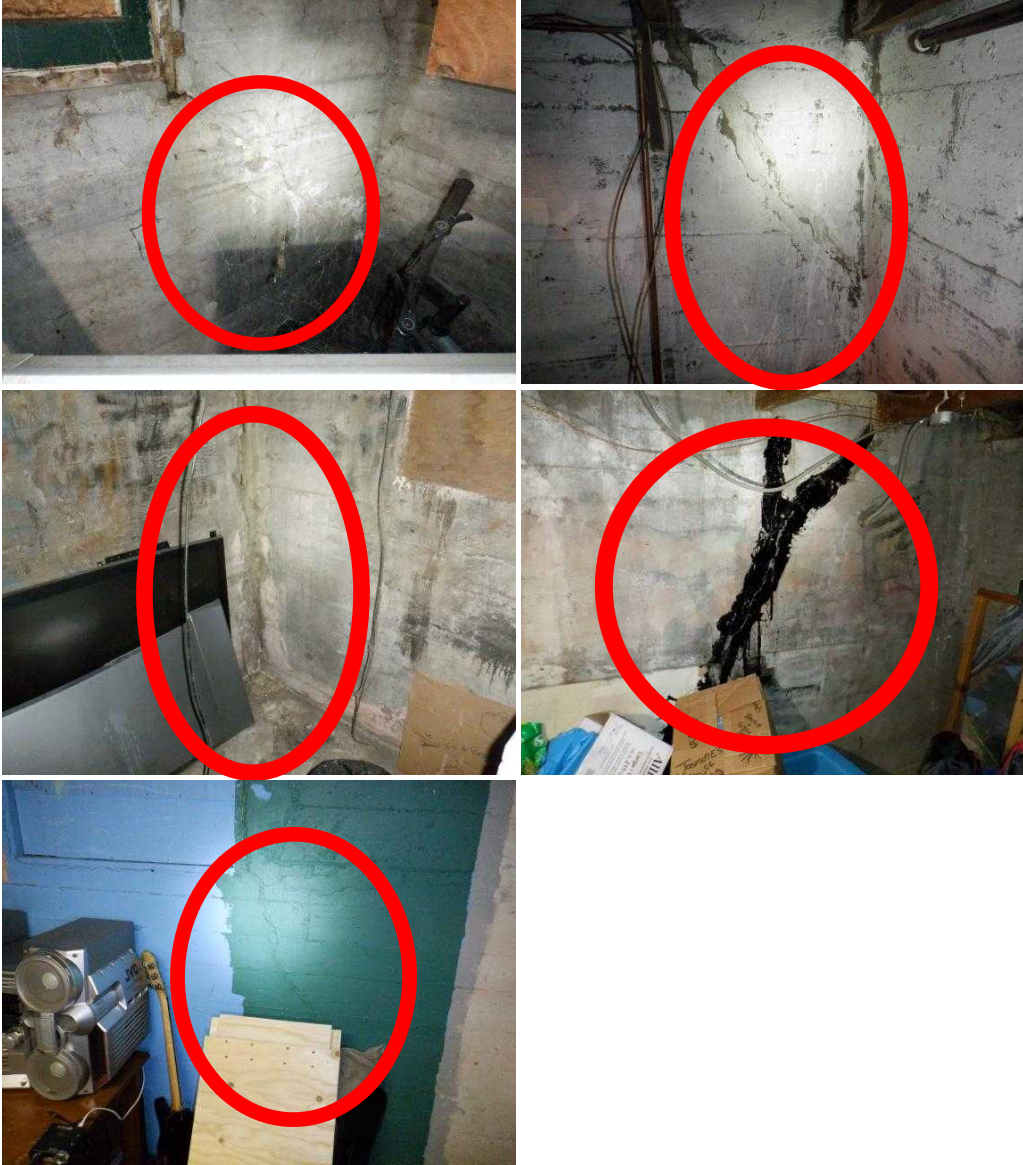
4. Foundation: Visible Portion Was Concrete - Portions of the foundation on the interior of the building was not visible due to finished wall coverings. Previous foundation repairs noted. Owner may have insight to extent of the repairs and if any warranty covers the repairs. Cracks will require monitoring, if movement or moisture entry noted, recommend epoxy injection be performed. Larger cracks with displacement should be addressed immediately. Recommend repairs by a qualified foundation contractor.

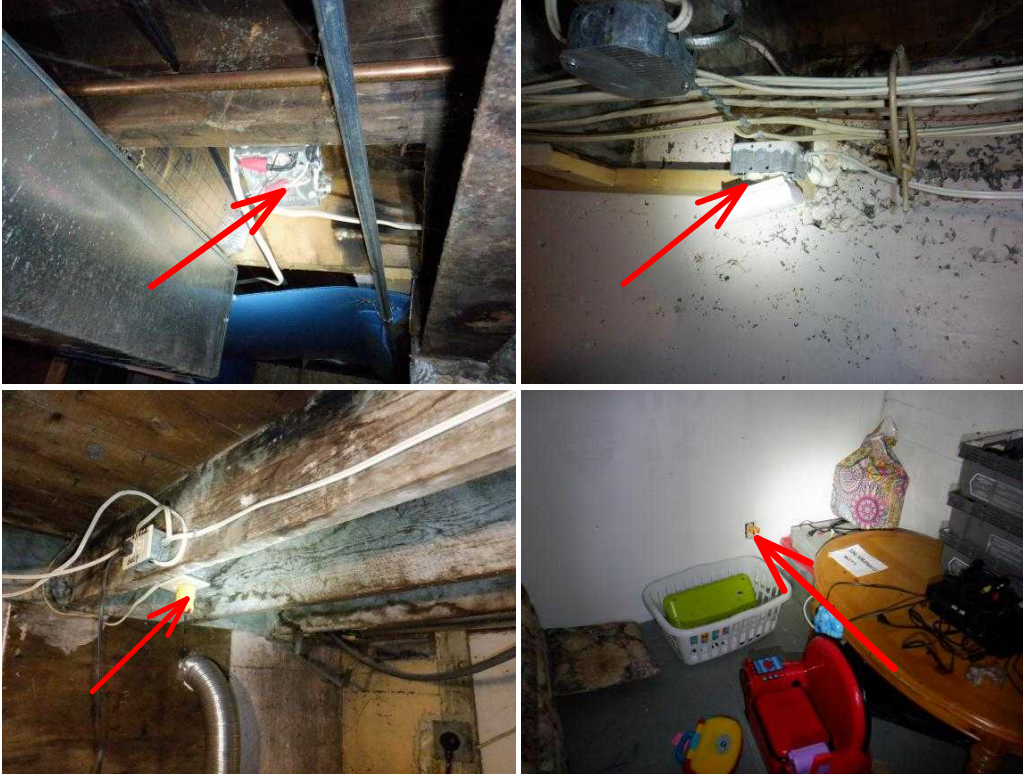
5. Entire Basement Area - Unit 414 Basement Electrical: 110 VAC Outlets and Lighting Circuits - Install missing cover plates on junction boxes, outlets and switches. Open grounds noted. Recommend repairs by a qualified electrician.

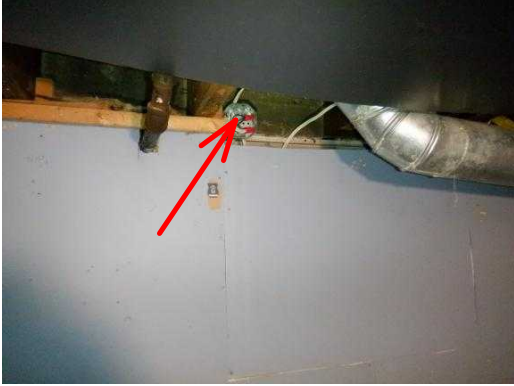
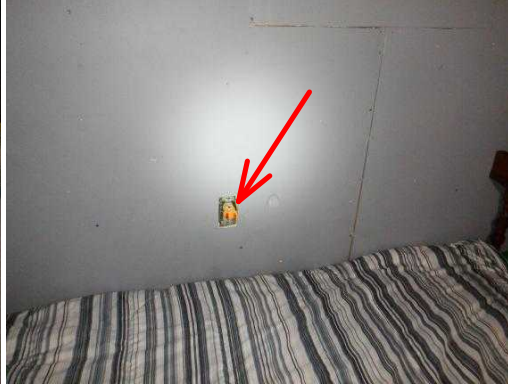
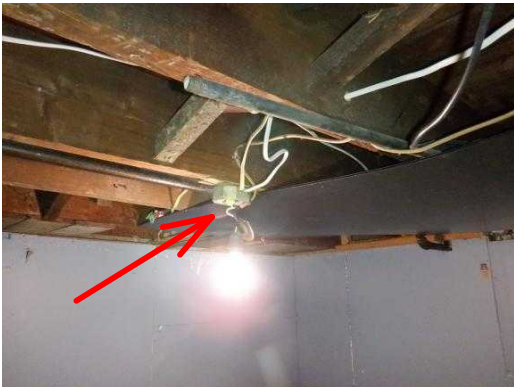
6. Entire Basement Area - Unit 416 Basement Electrical: 110 VAC Outlets and Lighting Circuits - Install missing cover plates on junction boxes, outlets and switches. Replace damaged cover plates. Loose light fixtures should be secured to prevent movement and potential wiring becoming loose. Open grounds noted. Recommend repairs by a qualified electrician.

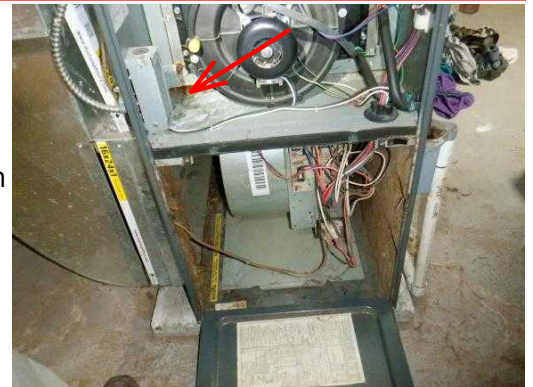
7. Basement Unit 418 Heating System Heating System Operation: Functional at time of the inspection - Unit is in serviceable condition, but is an older unit (17 Years) and should be regularly maintained. Life expectancy of a high efficiency furnace is 15 - 20 years. Service and cleaning recommended on an annual basis to ensure proper function and to prolong the stated design life of the unit. Ongoing condensate leak requires immediate repairs.

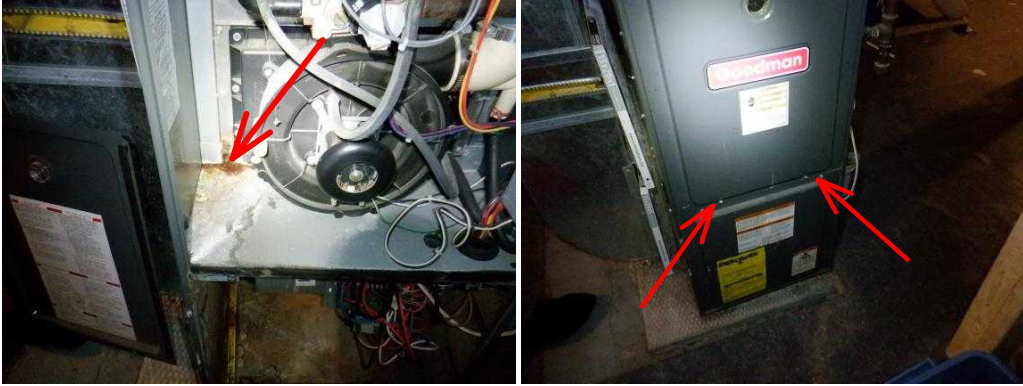
8. Basement Unit 414 Heating System Heating System Operation: Functional at time of the inspection - Unit is in serviceable condition, but is an older unit (17 years) and should be regularly maintained. Life expectancy of a high efficiency furnace is 15 - 20 years. Ongoing condensate leak noted. Recommend immediate repairs. Service and cleaning recommended on an annual basis to ensure proper function and to prolong the stated design life of the unit. Replace stripped cover screws.

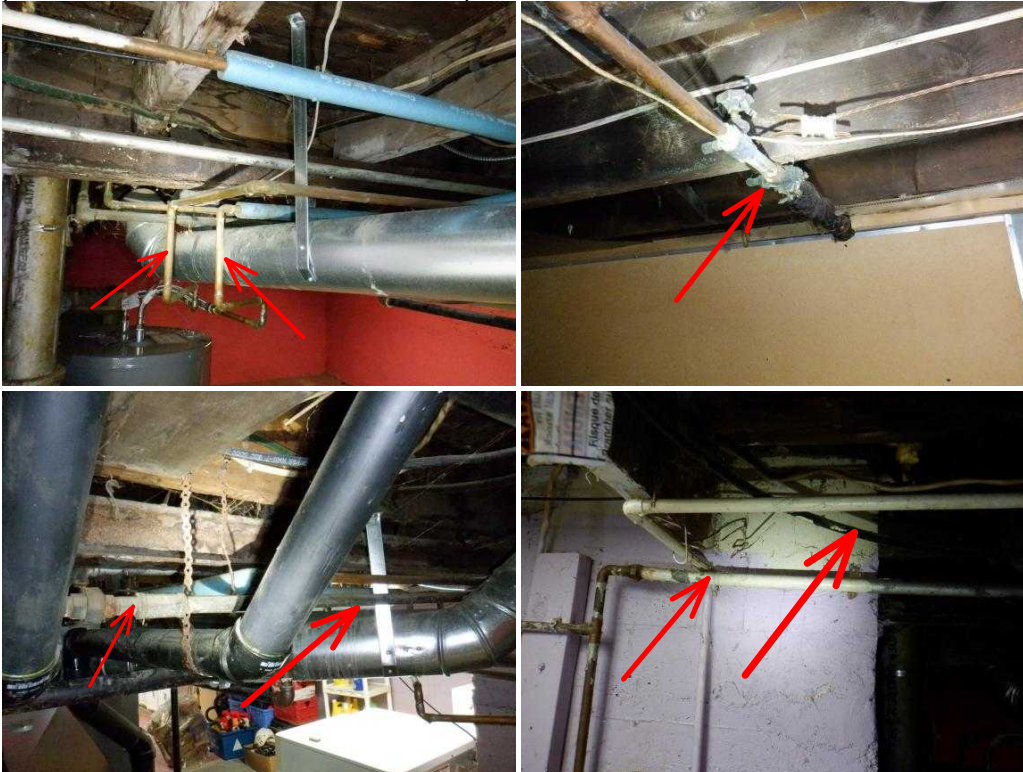
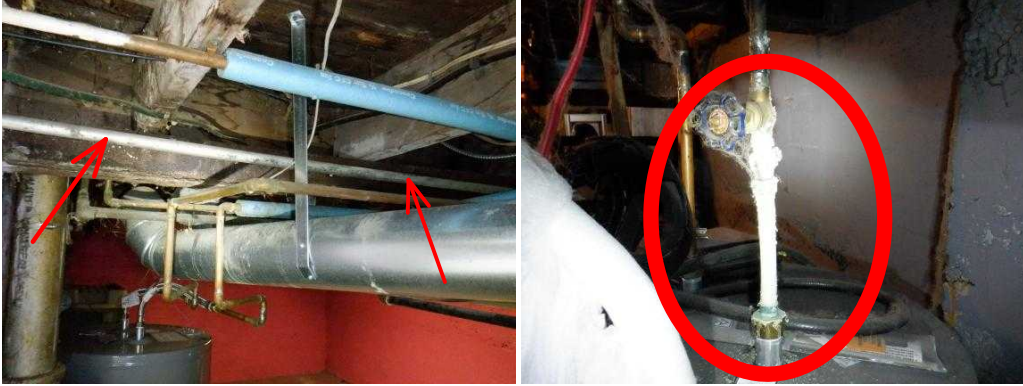
9. Water Lines: All visible water lines were copper, PEX, Galvanized - Some water supply piping was not visible due to interior finishing. Some corrosion was noted on areas of the water lines but no leakage was present at time of the inspection. Monitor. Some water lines were in contact with duct work. This situation will likely cause condensation at times. Recommend insulating between water lines and duct work Unit 418. Galvanized supply piping present in Units 416 and 418. Galvanized corrodes from inside causing decreased flow-rates and will require updating. Update may be required for insurance purposes. Corrosion and leakage of water lines was present in Unit 416. A licensed plumber is recommended to evaluate and estimate repairs

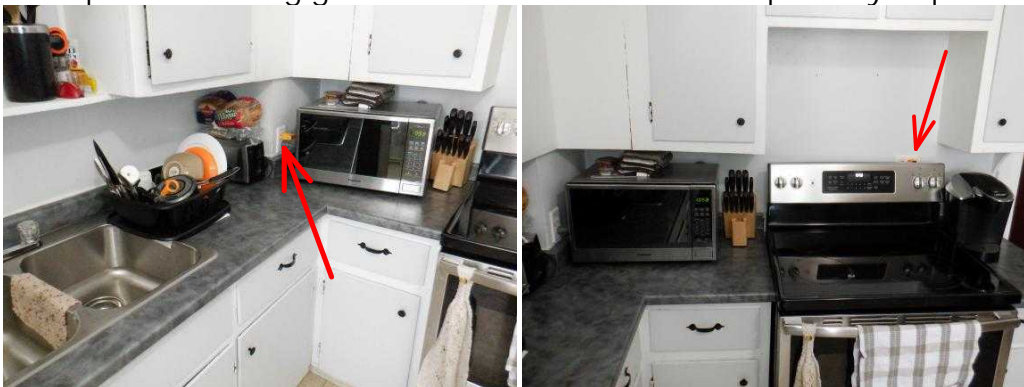
11. Main Floor Kitchen Area - 412 Kitchen Electrical: 110 - 240 VAC outlets and 110 VAC lighting circuits - Recommend installing GFCI outlets above countertop area within close proximity of the sink. Open or missing grounds noted. Recommend repairs by a qualified electrician.

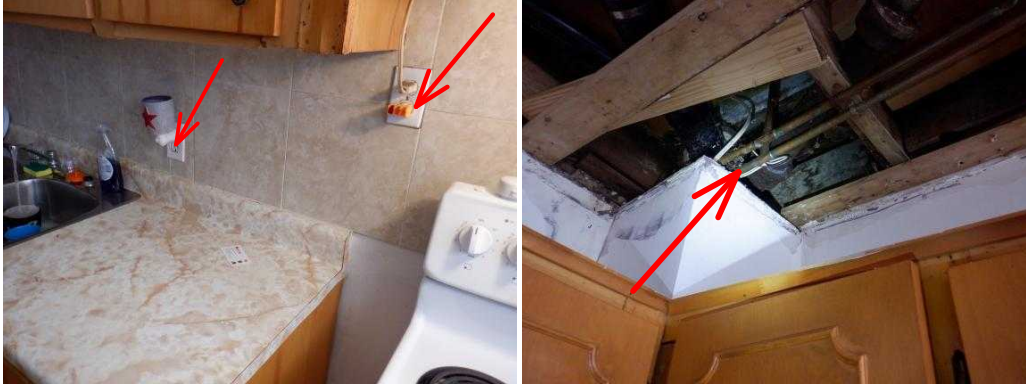
12. Main Floor Kitchen - Unit 414 Kitchen Electrical: 110 - 240 VAC outlets and 110 VAC lighting circuits - Recommend installing GFCI outlets above countertop area within close proximity of the sink. Loose outlets should be secured to prevent movement and potential wiring becoming loose. Open or missing ground noted. Recommend proper and full termination of all unused outlets. Recommend repairs by a qualified electrician.

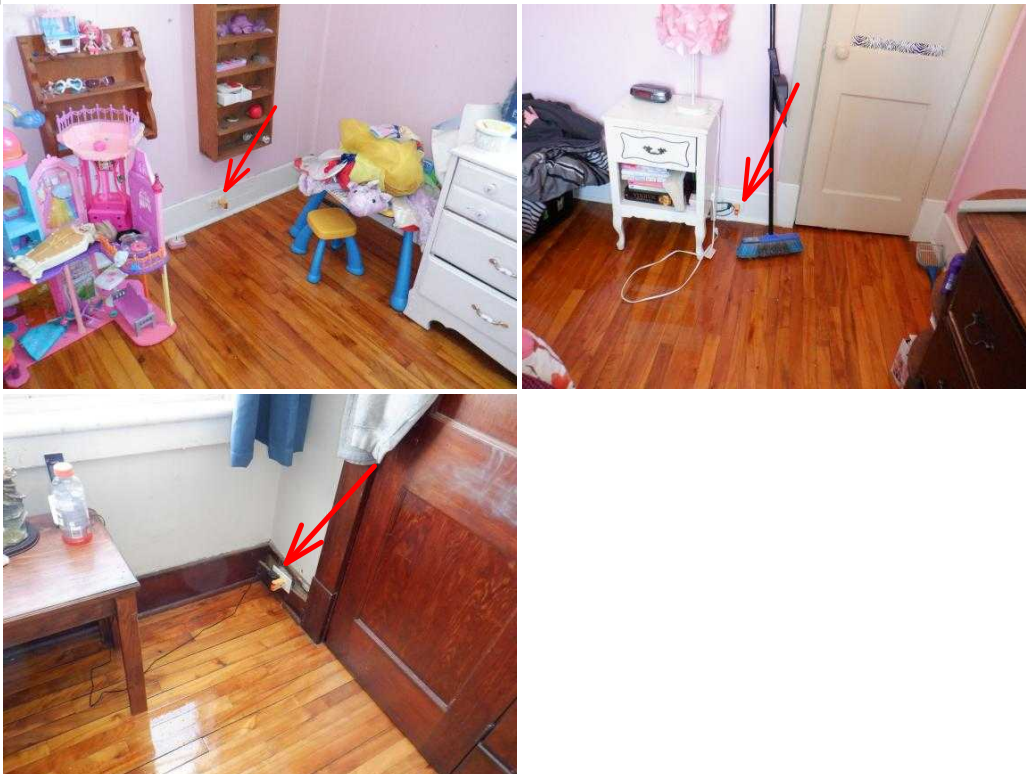
13. Living Room, Dining Area, Bedrooms, Hall and Entrance - Unit 410 Living Space Electrical: 110 VAC Outlets and Lighting Circuits - Loose outlets should be secured to prevent movement and potential wiring becoming loose. Open or missing grounds noted. Recommend repairs by a qualified electrician.

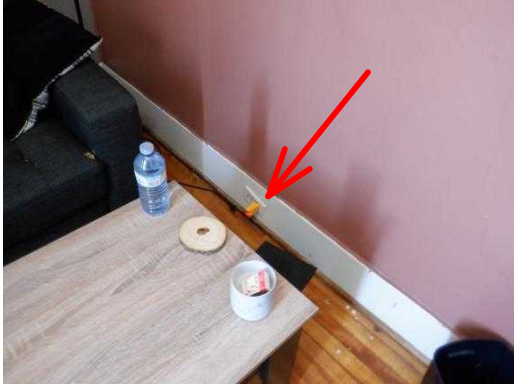
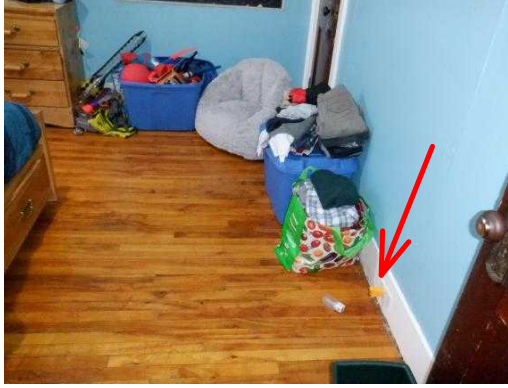
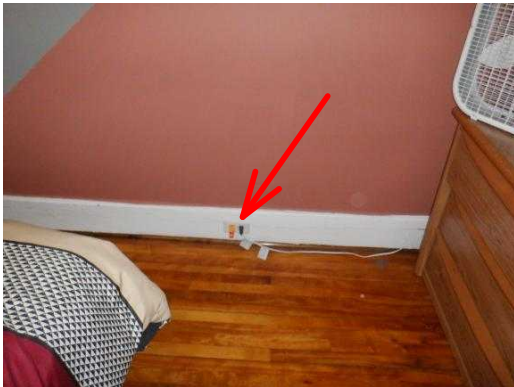
14. Living Room, Dining Area, Bedrooms, Hall and Entrance Area - 412 Living Space Electrical: 110 VAC Outlets and Lighting Circuits - Open or missing grounds noted. Recommend repairs by a qualified electrician.

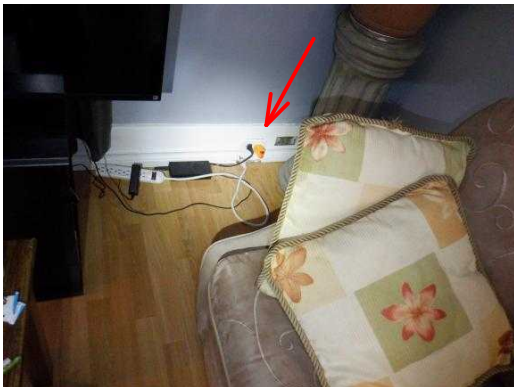
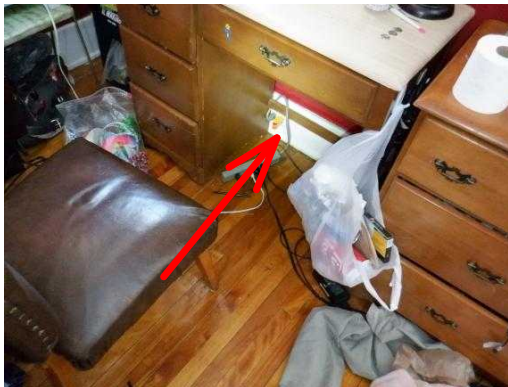
15. Living Room, Dining Area, Bedrooms, Hall and Entrance Area - Unit 414 Living Space Electrical: 110 VAC Outlets and Lighting Circuits - Some outlets were not accessible to test due to the vast amount of clutter present. Loose outlets should be secured to prevent movement and potential wiring becoming loose. Open or missing grounds noted. Recommend repairs by a qualified electrician.
